# Sixth Street Viaduct Seismic Improvement Program Alkali Silica Reaction Workshop 8/27/08

# Alkali Silica Reaction (ASR) Material Finding at the Sixth Street Viaduct

# Visual Condition Survey

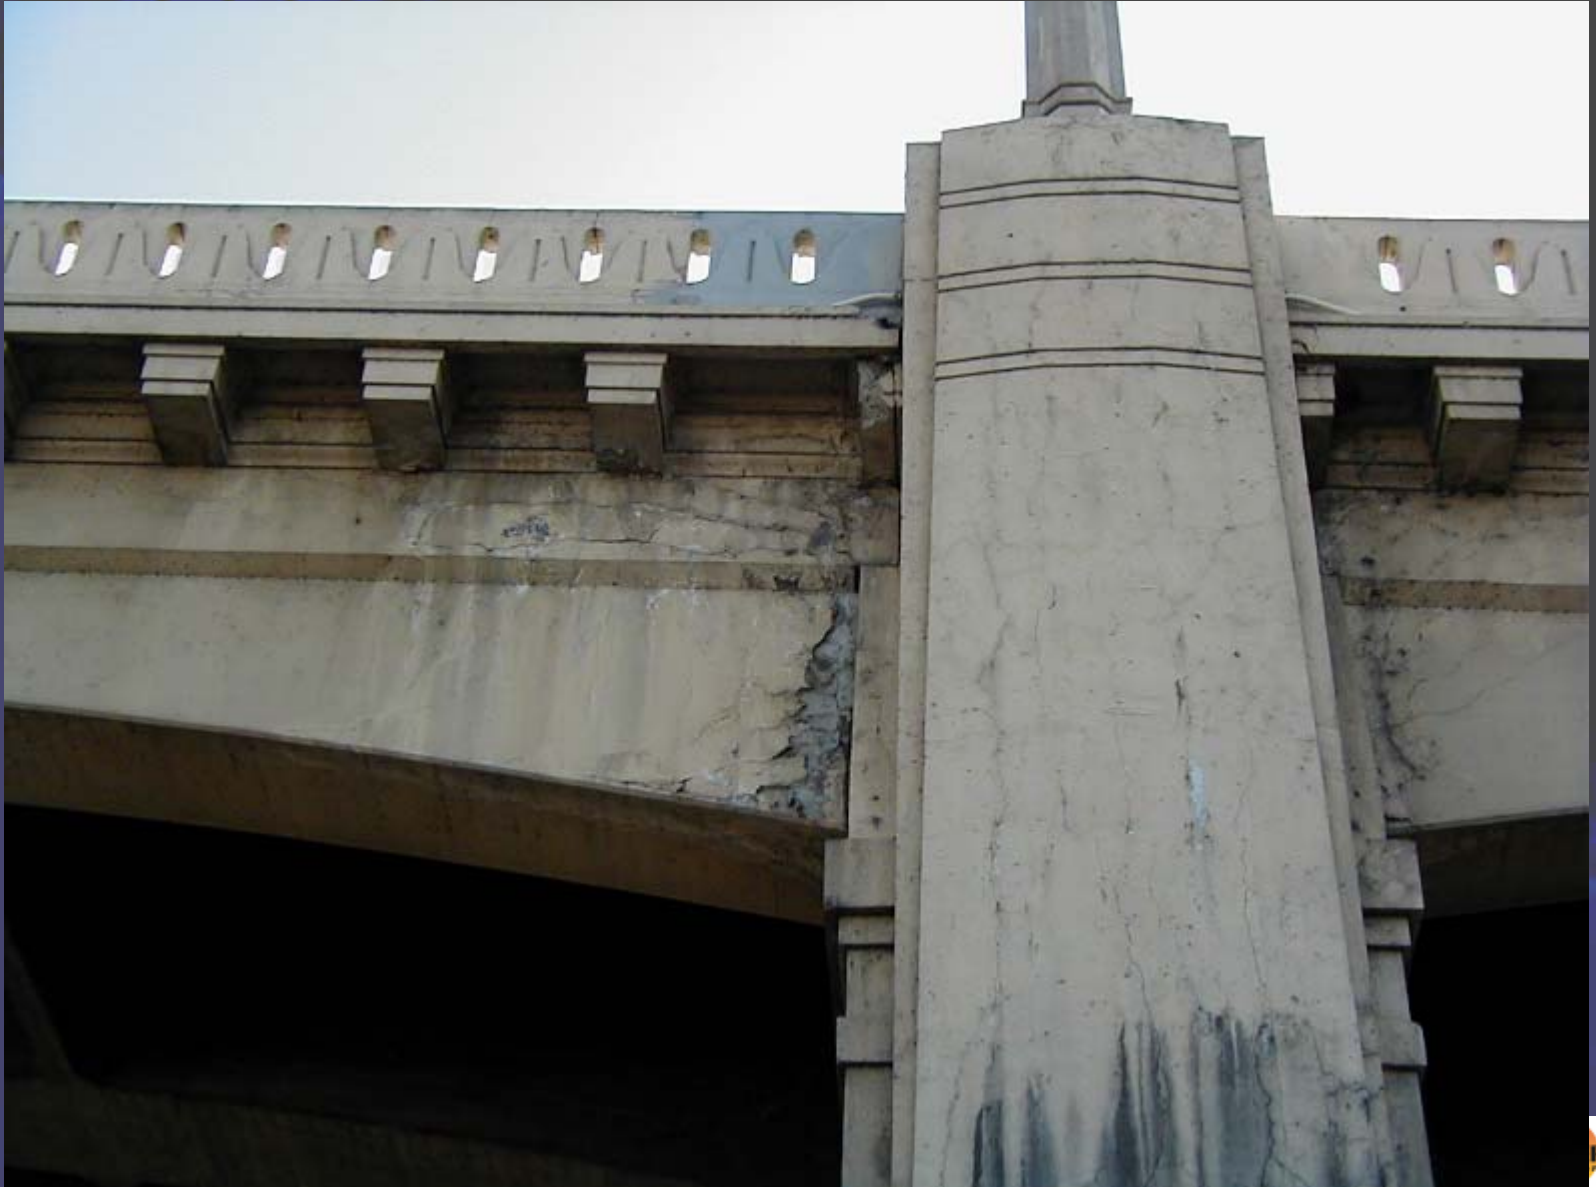
## Example of Severe Rating

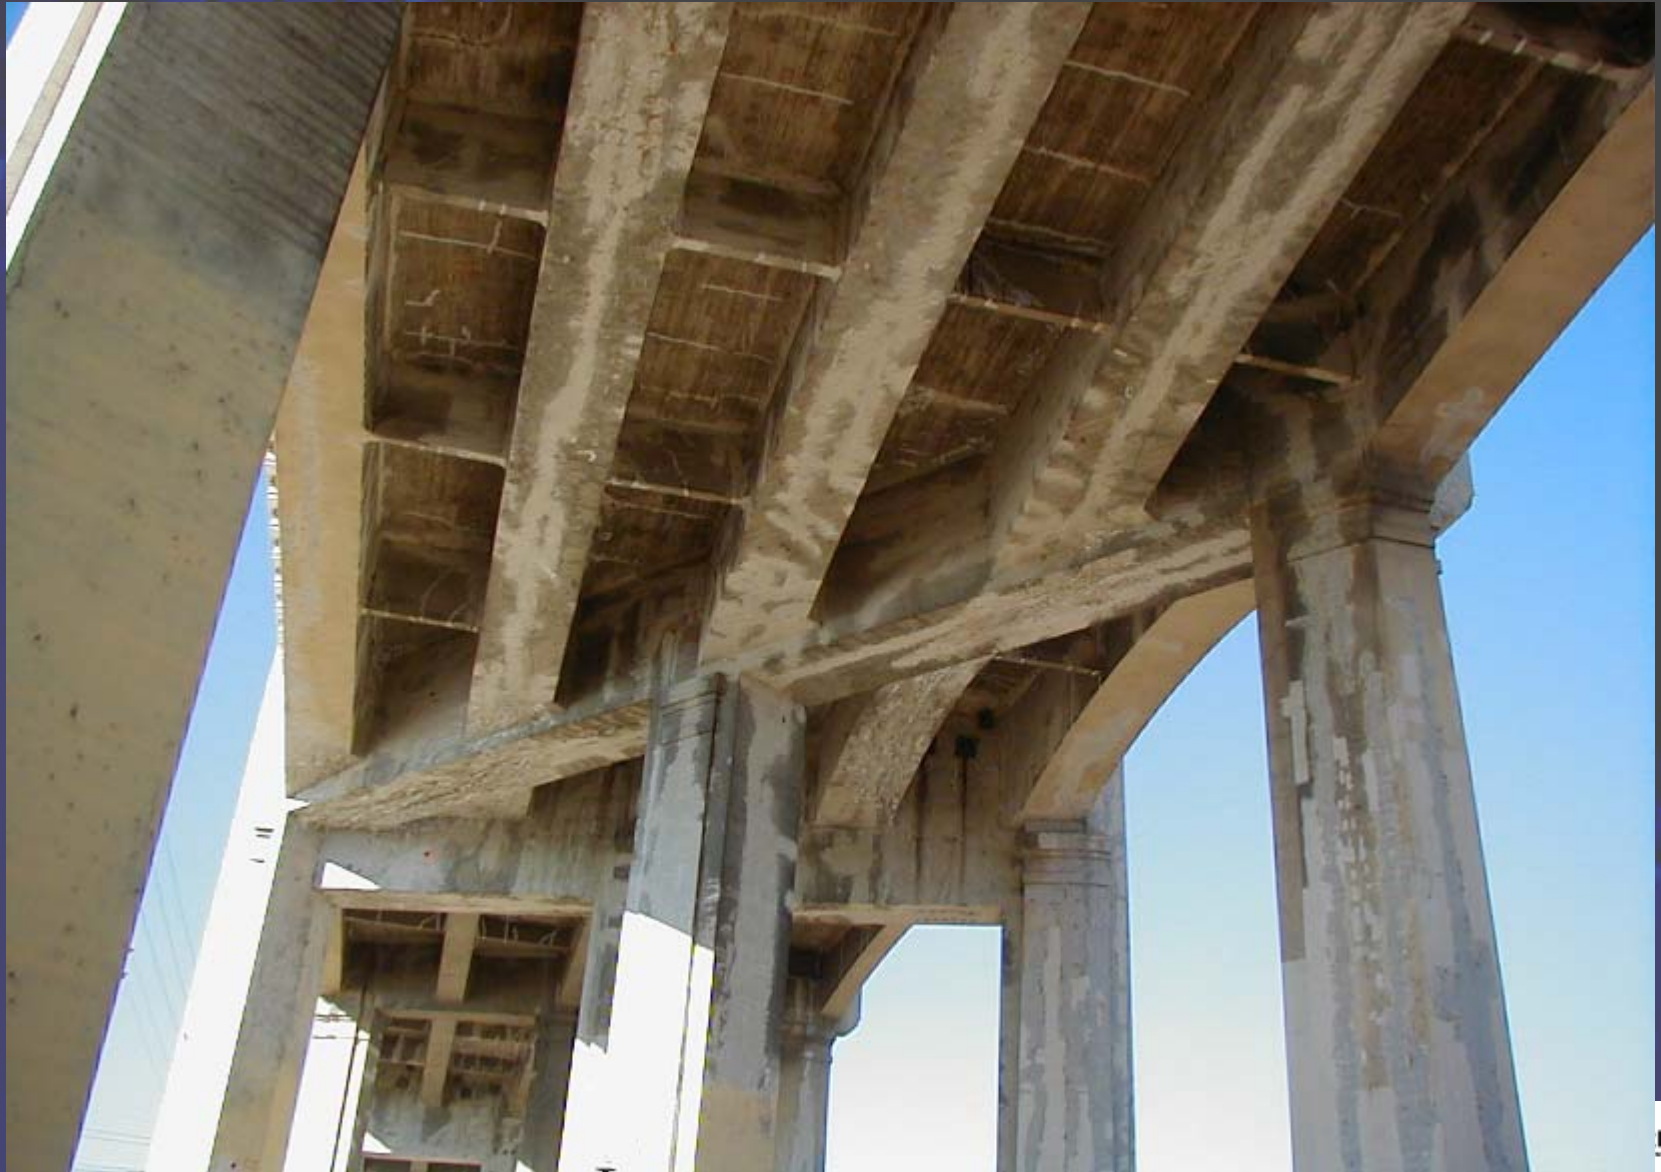
## Example of Severe Rating

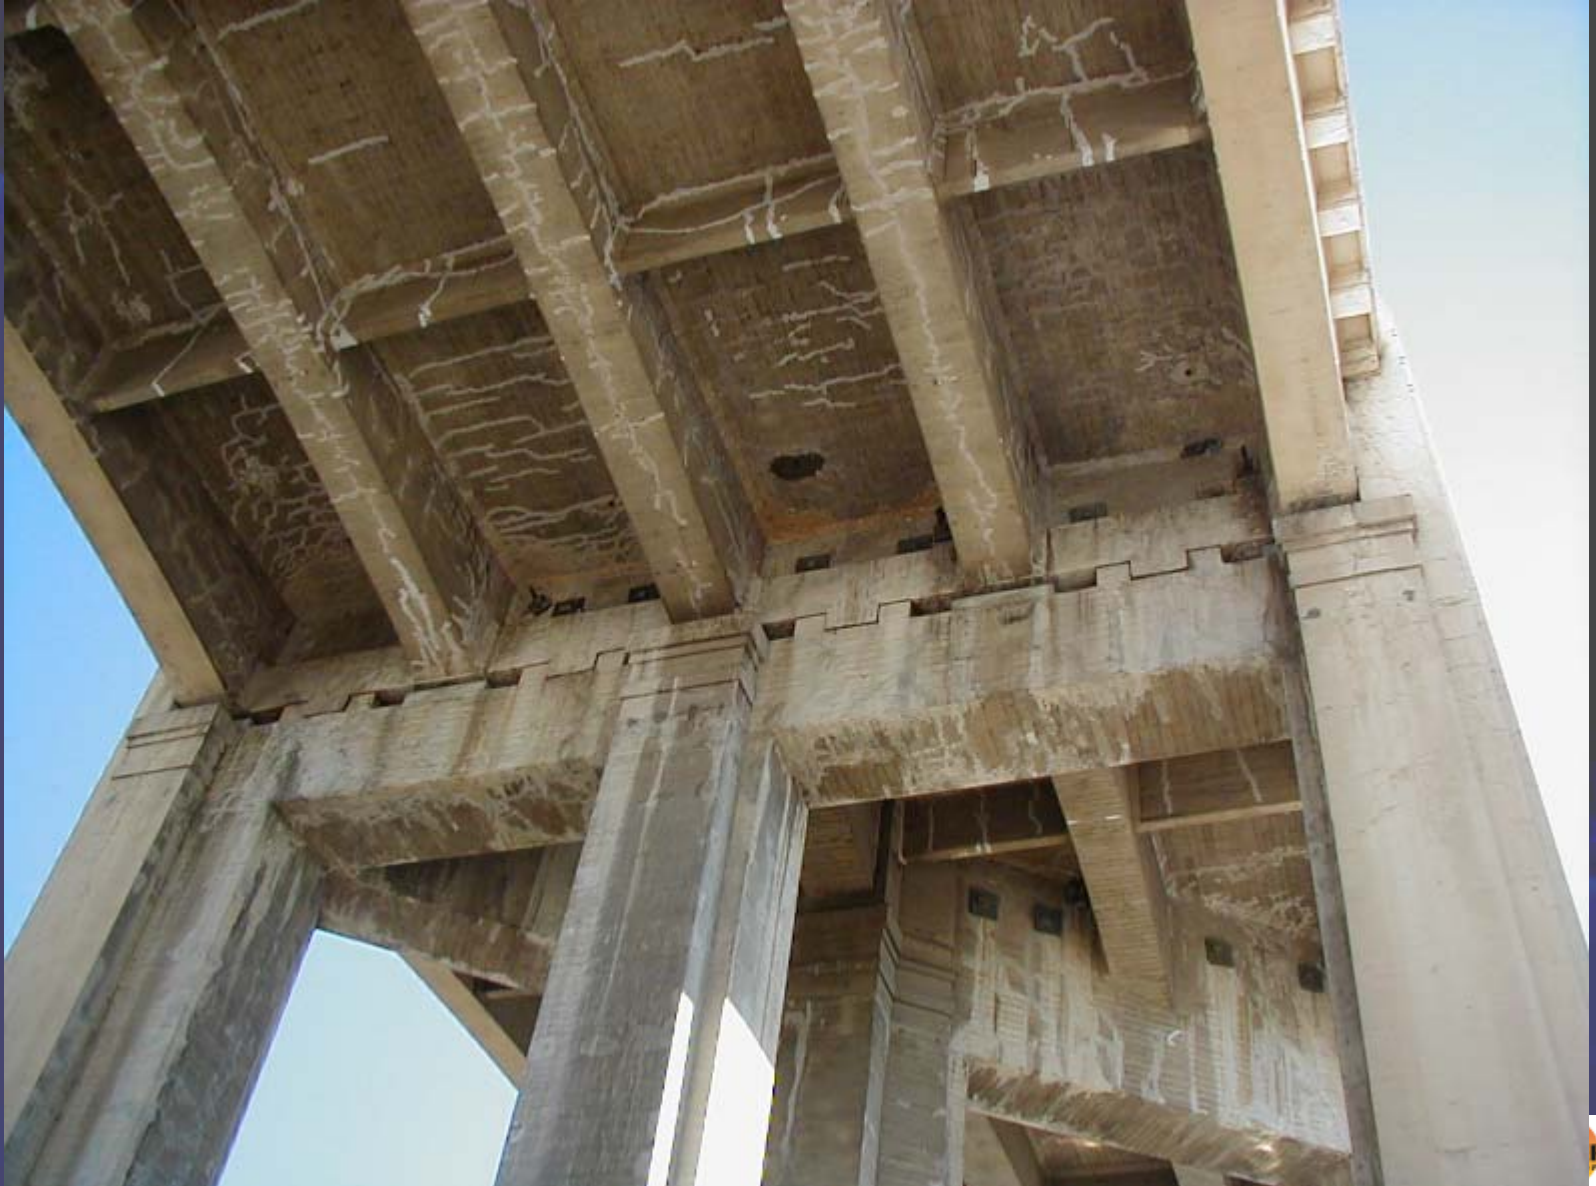
## Example of Severe Rating

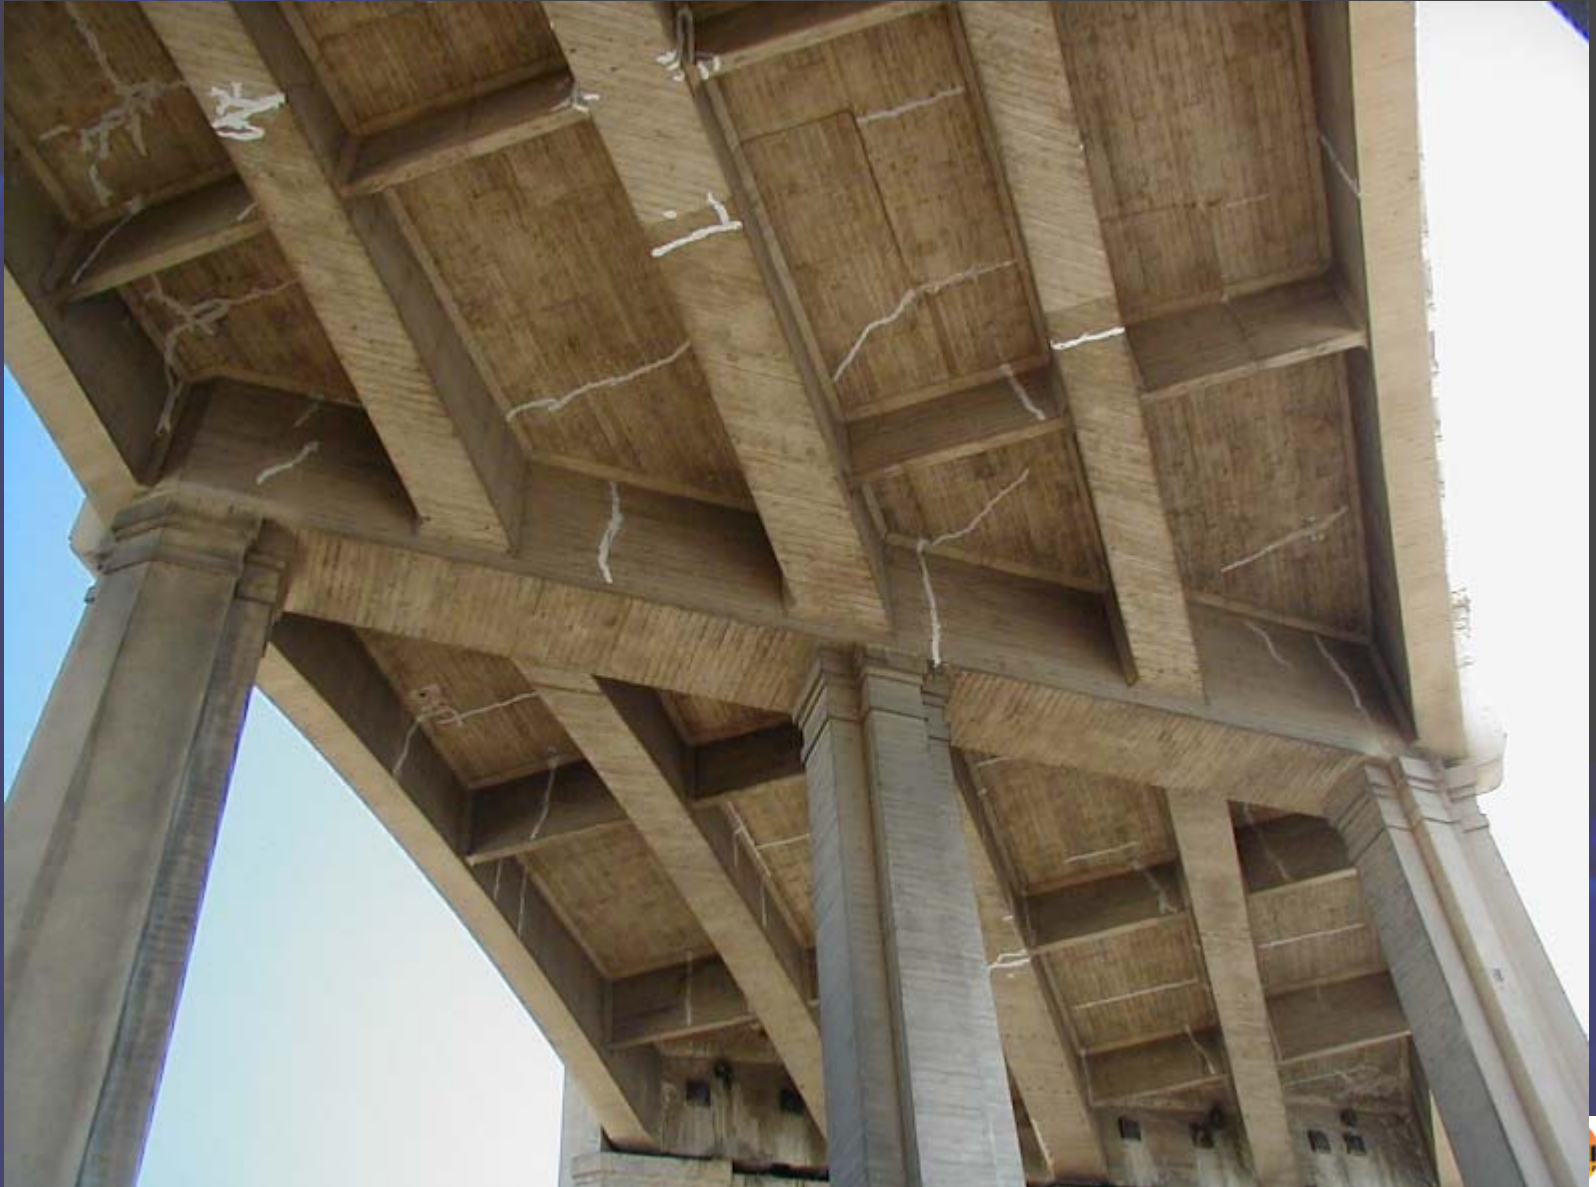
## Example of Light Rating

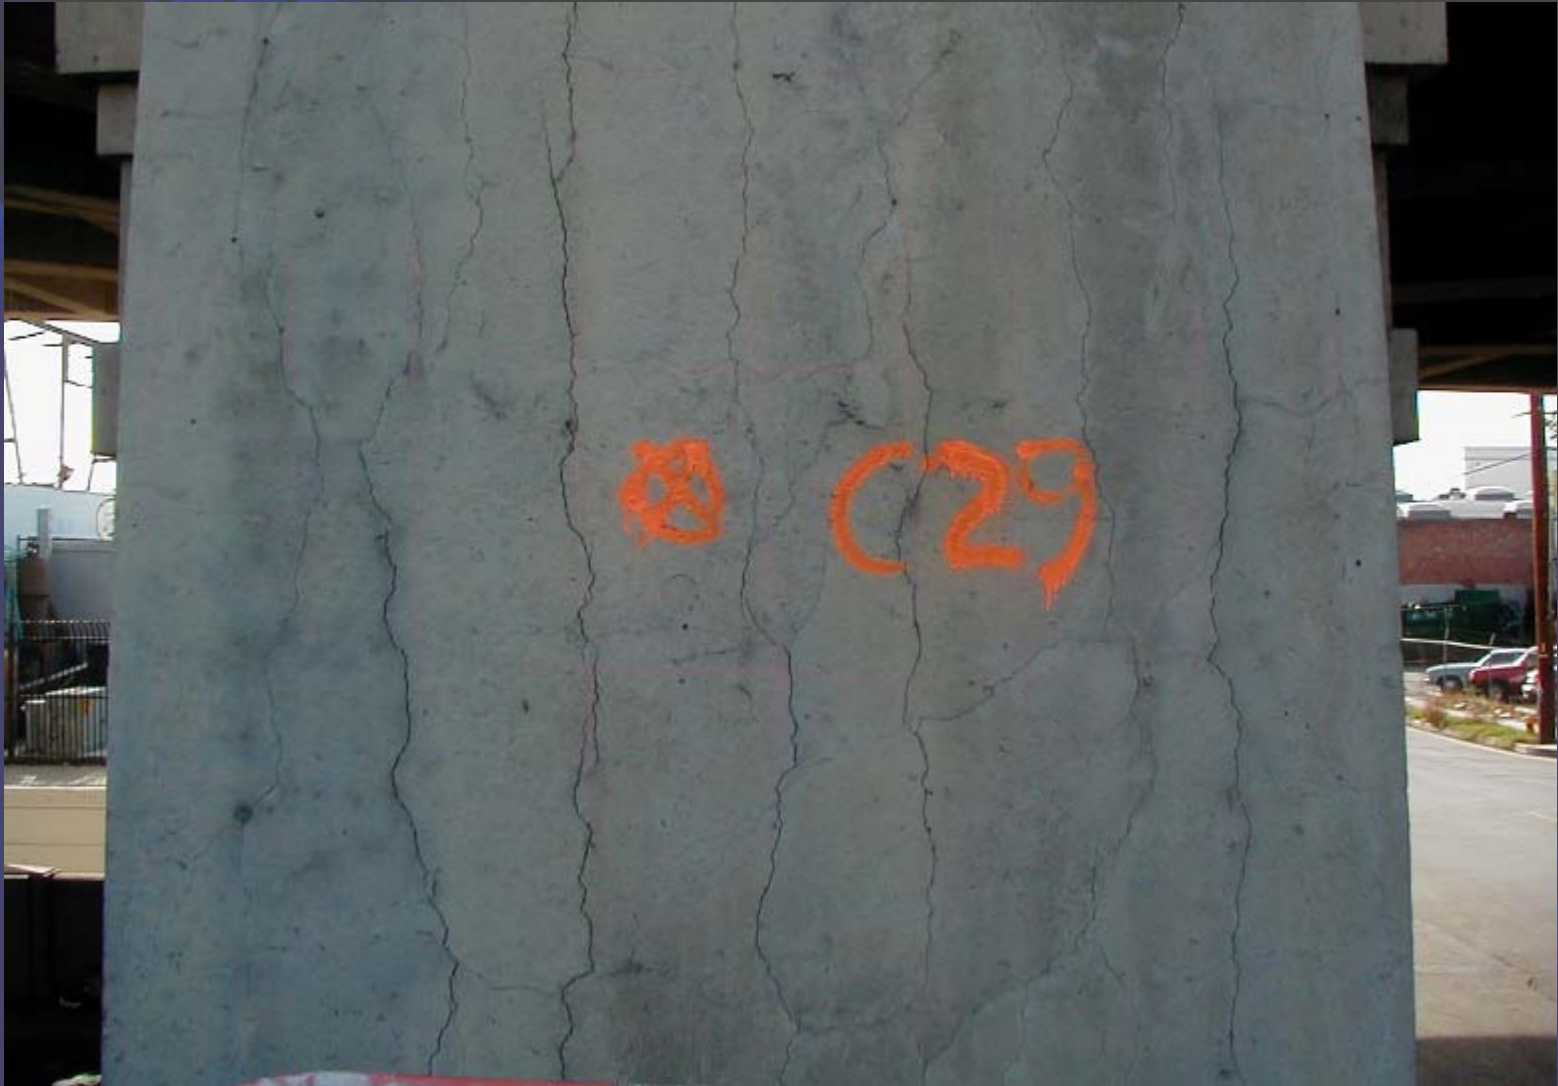
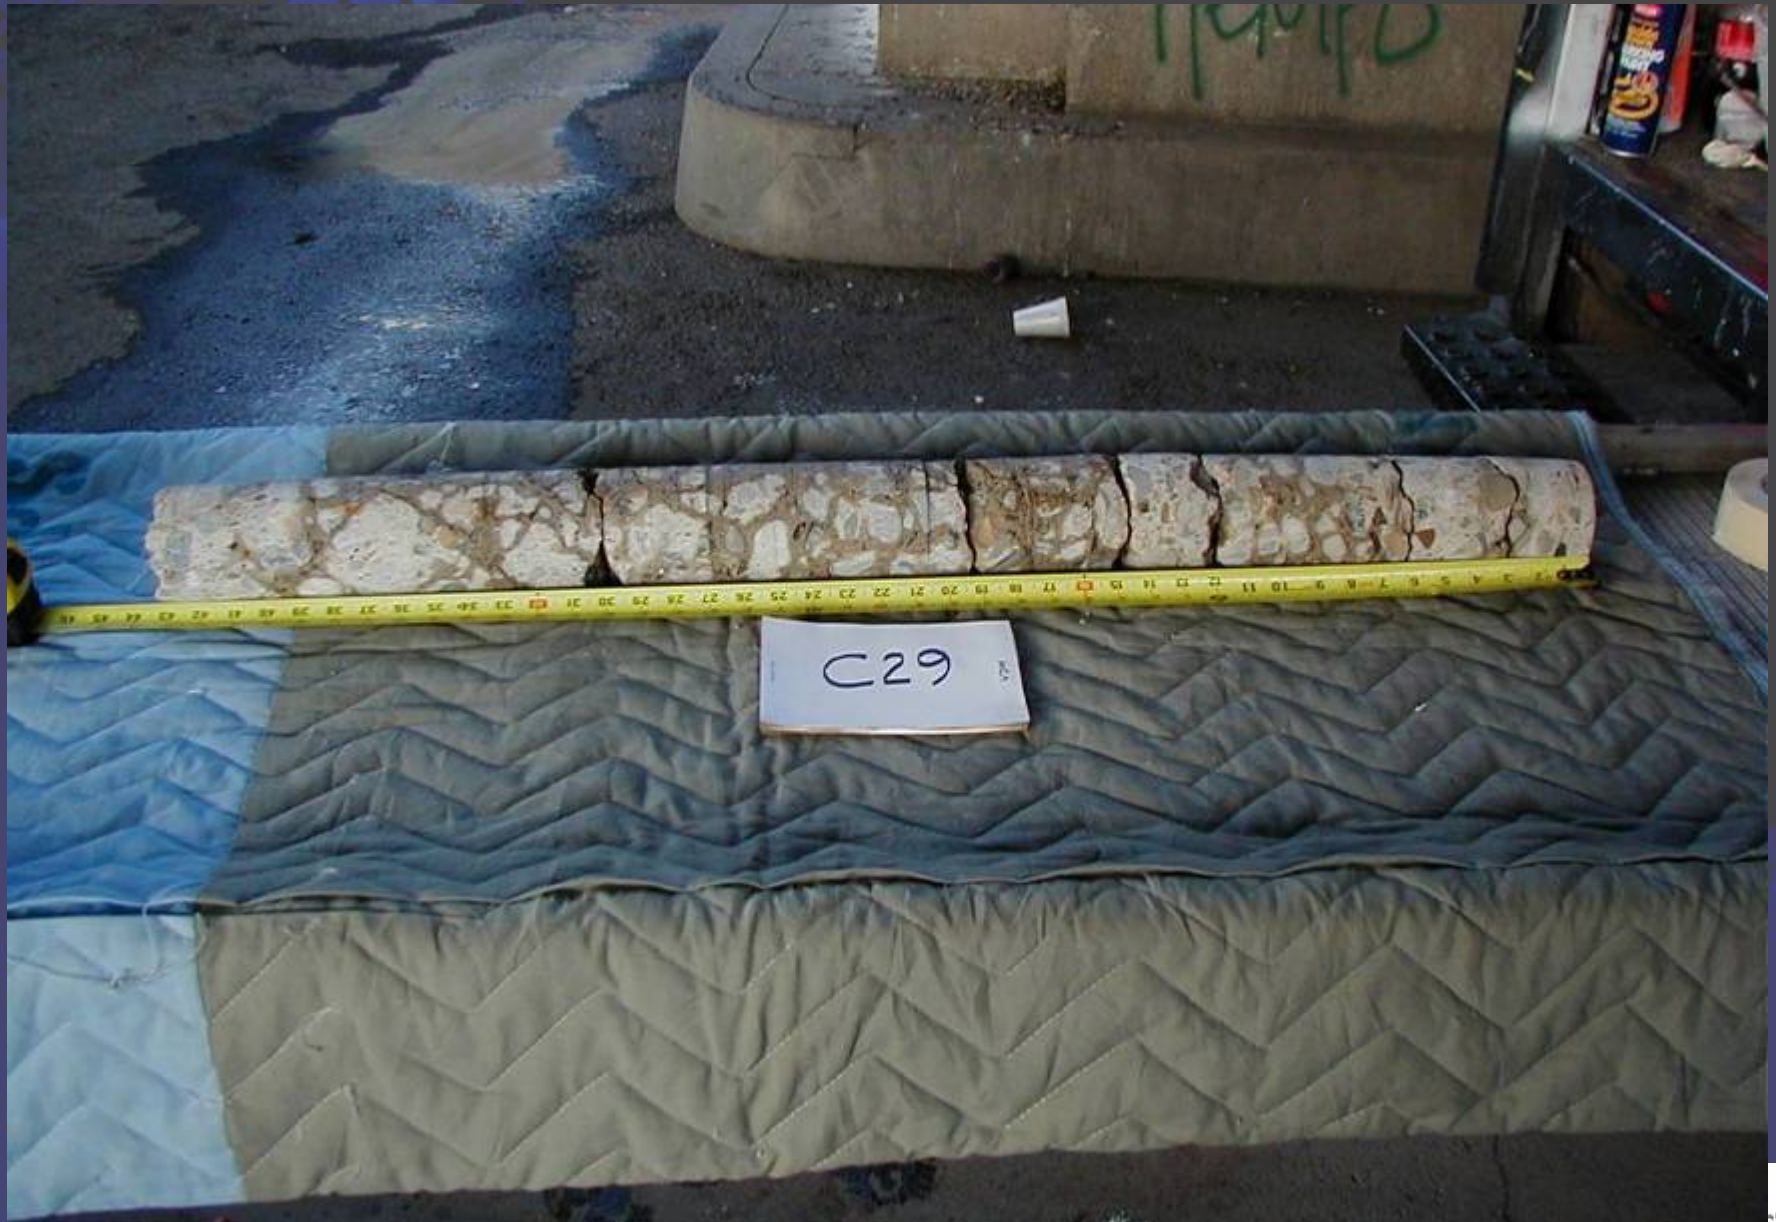
# Column Distress - N. Col., Bent 5

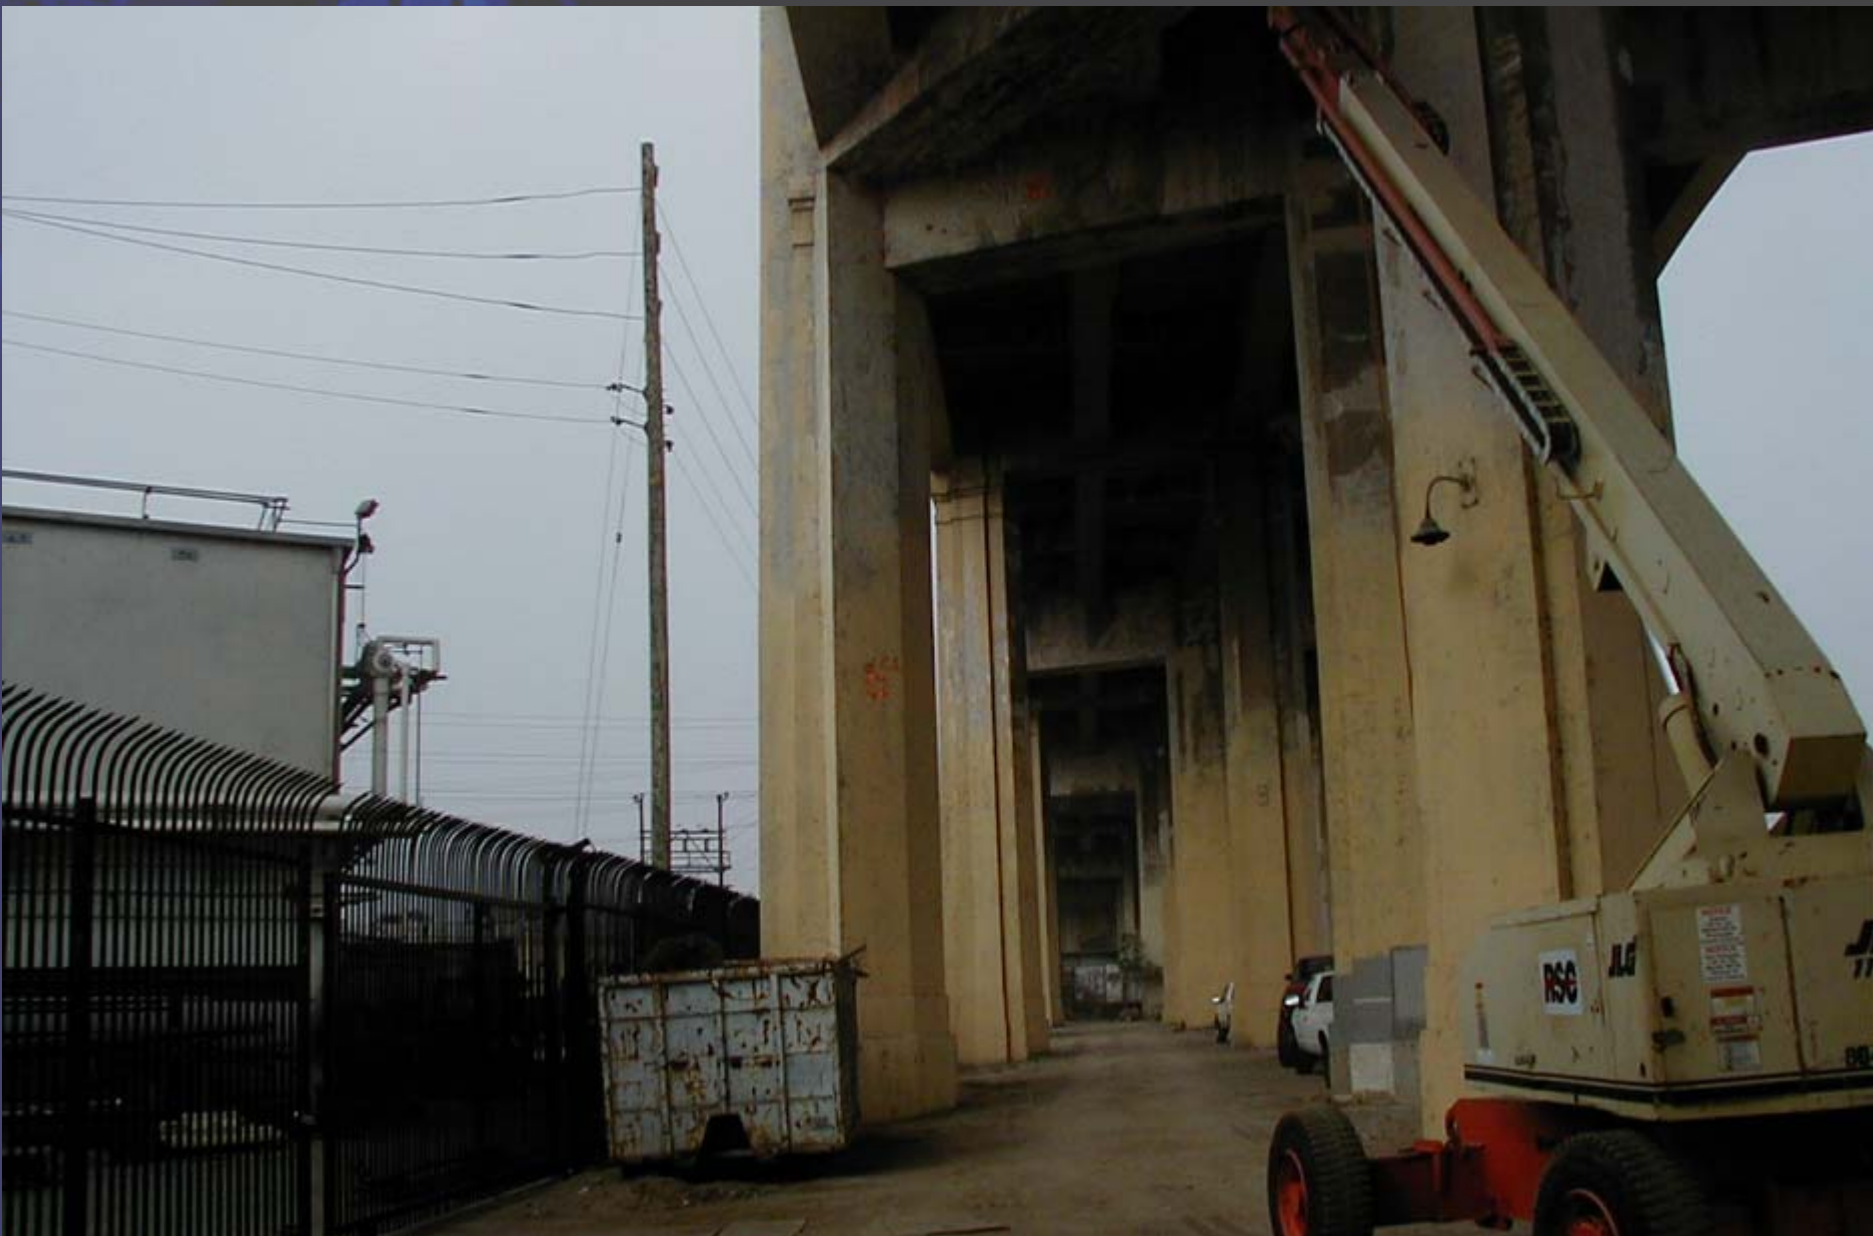
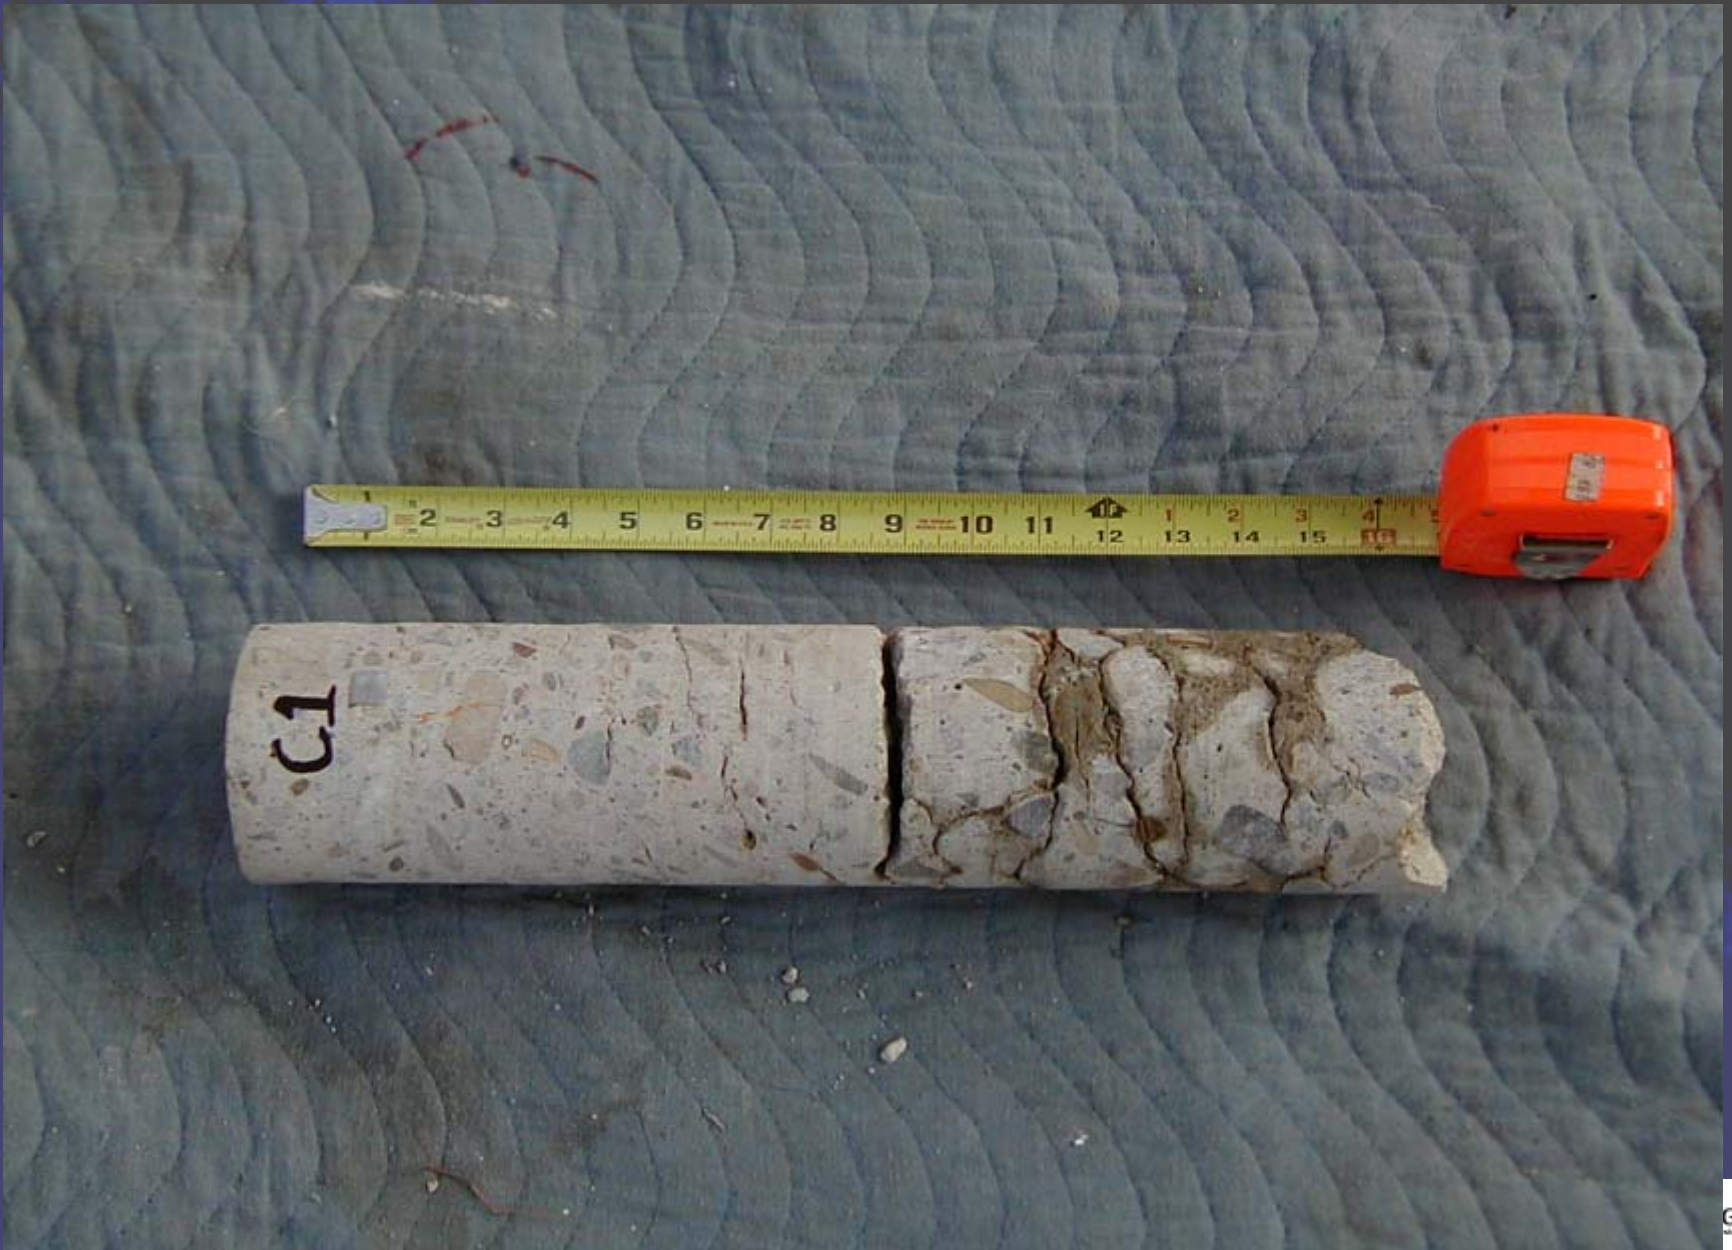
# Column Distress - S. Col., Bent 21

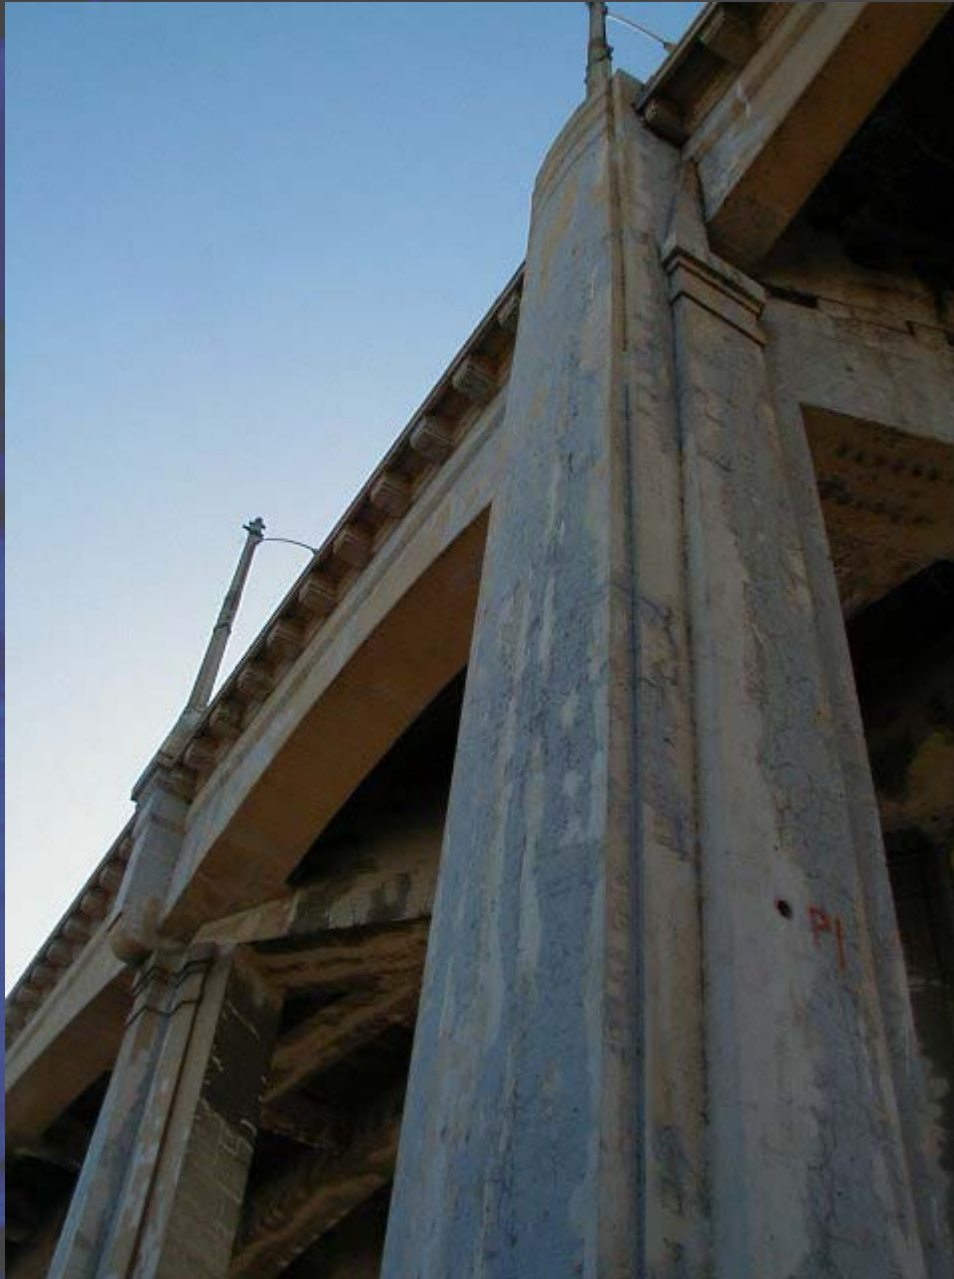
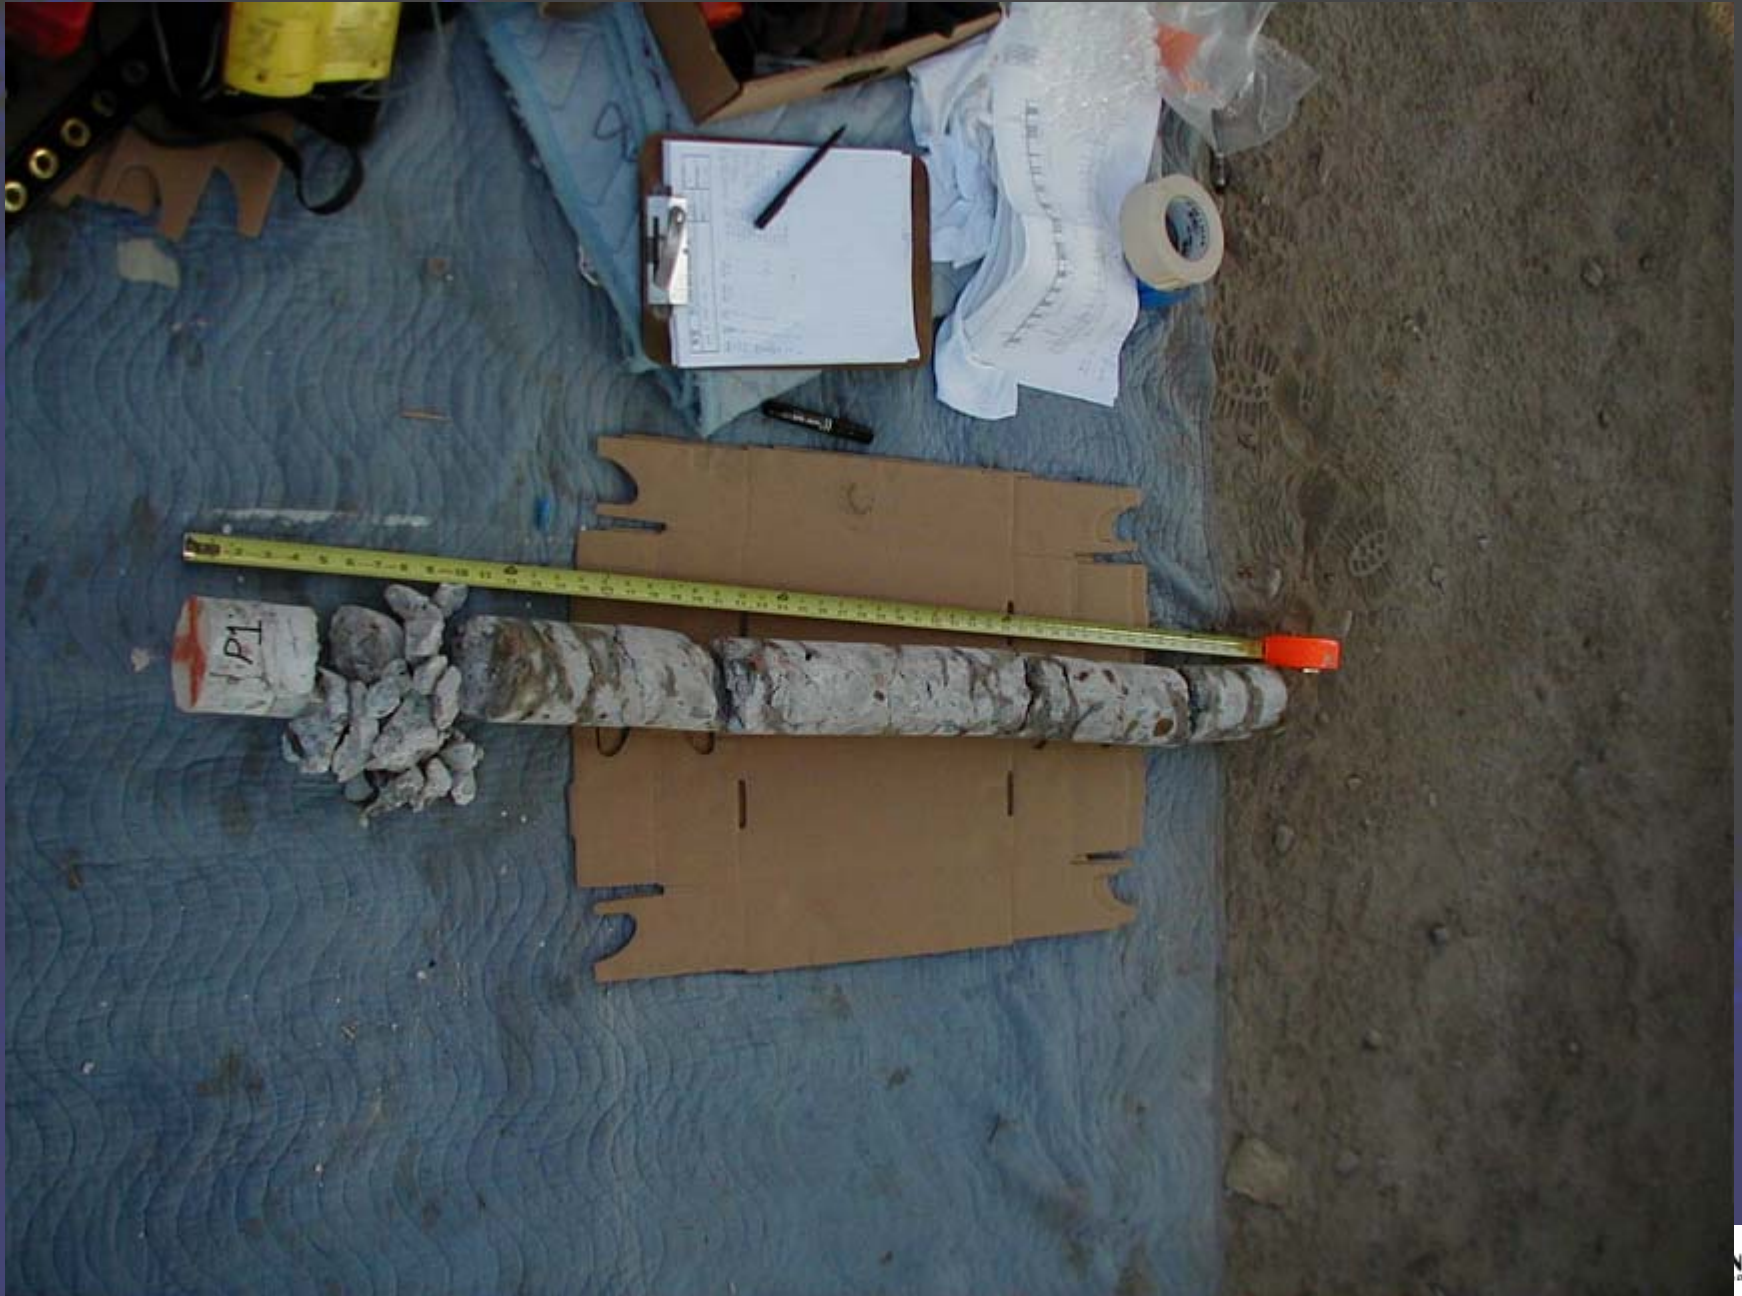
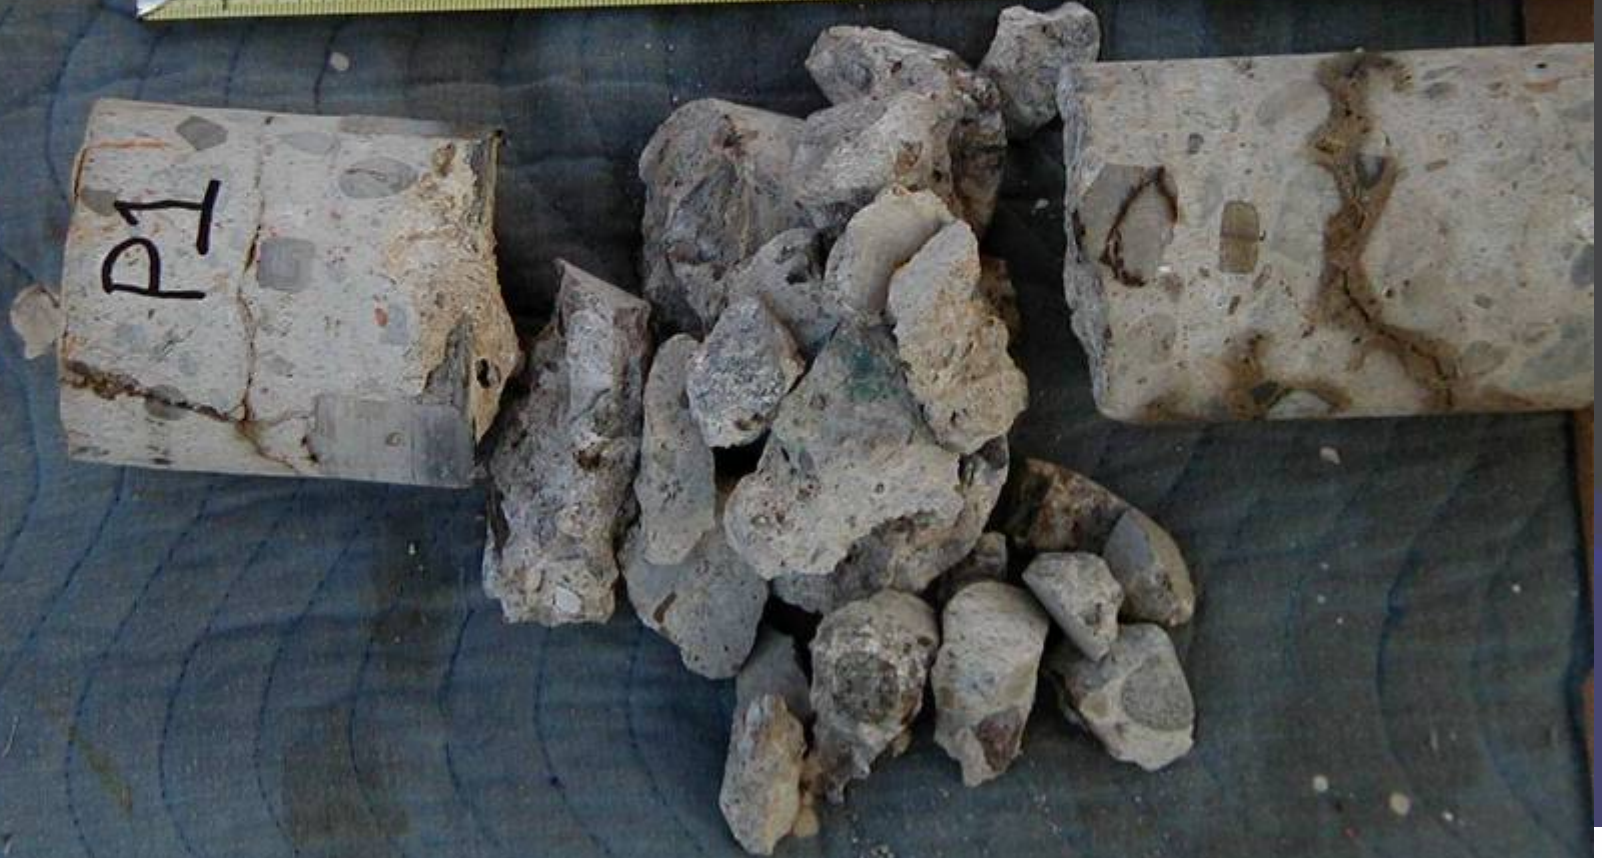
# Column Distress - N. Col., Bent 21

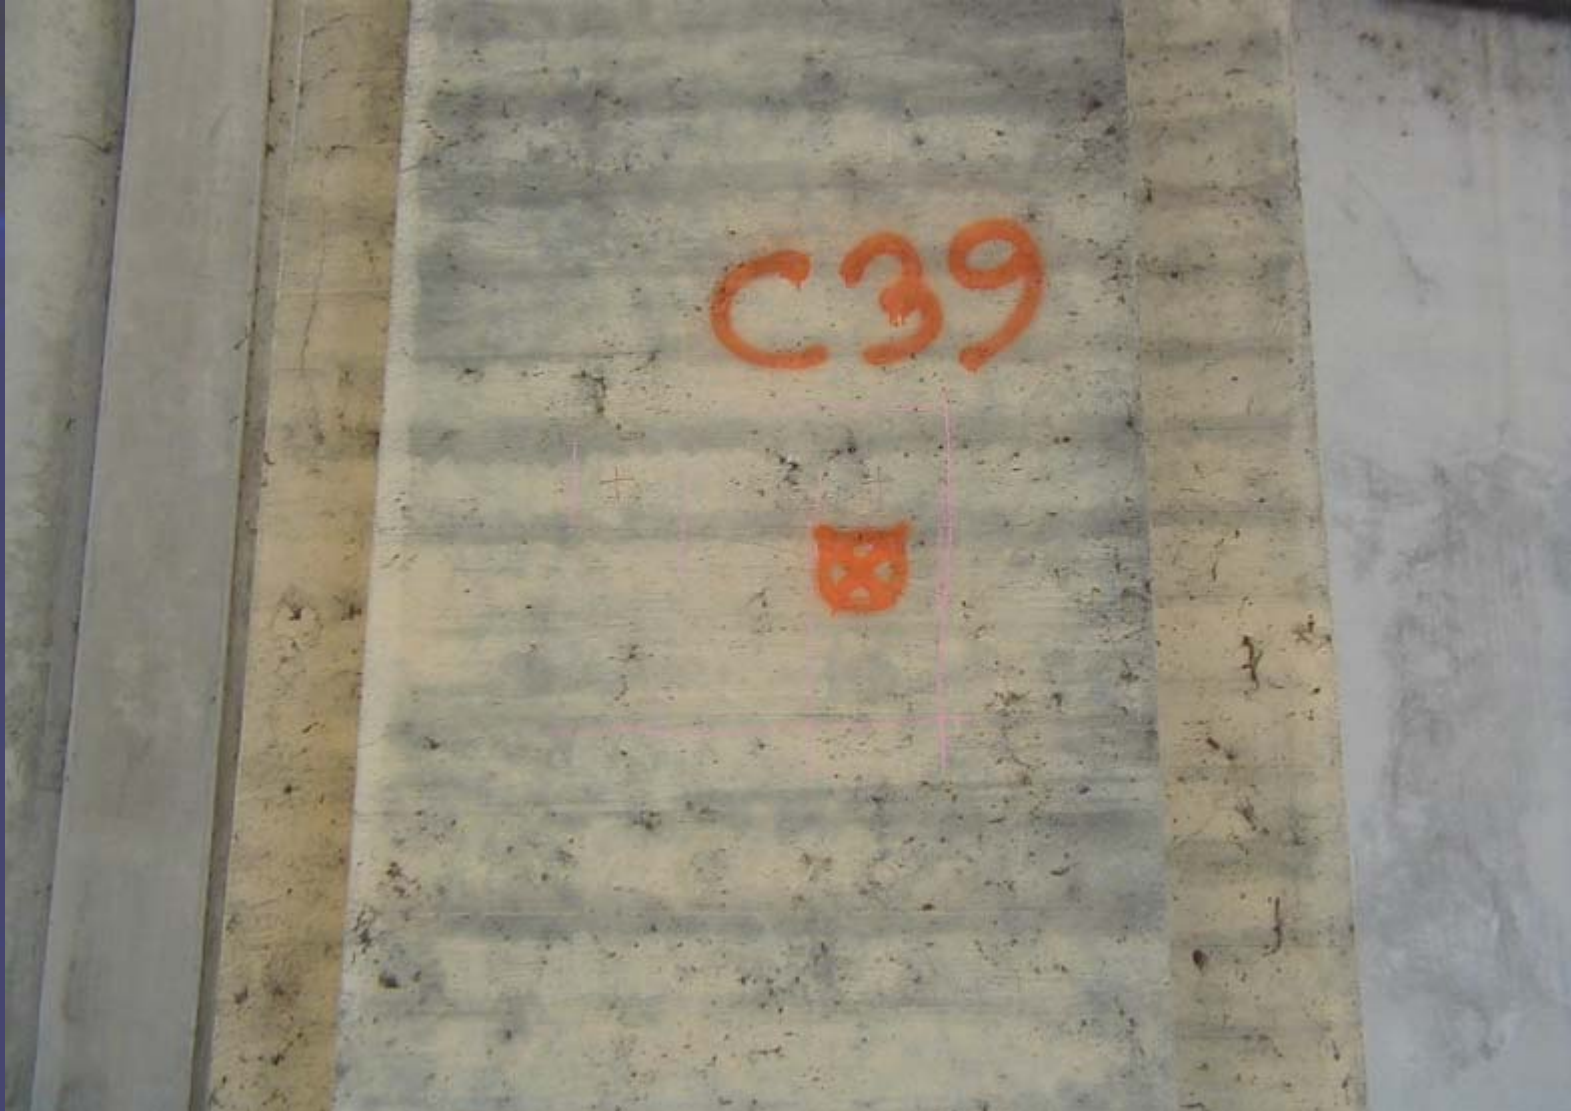
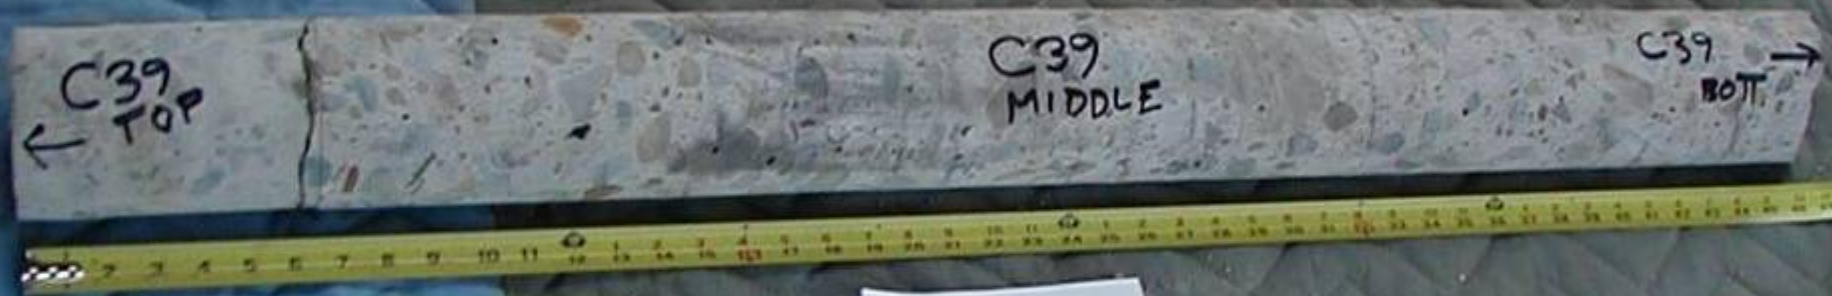
# Column Distress - S. Col., Bent 26
