# Sixth Street Viaduct Seismic Improvement Program Alkali Silica Reaction Workshop 8/27/08

# Alkali Silica Reaction (ASR) Material Finding at the Sixth Street Viaduct

# Visual Condition Survey

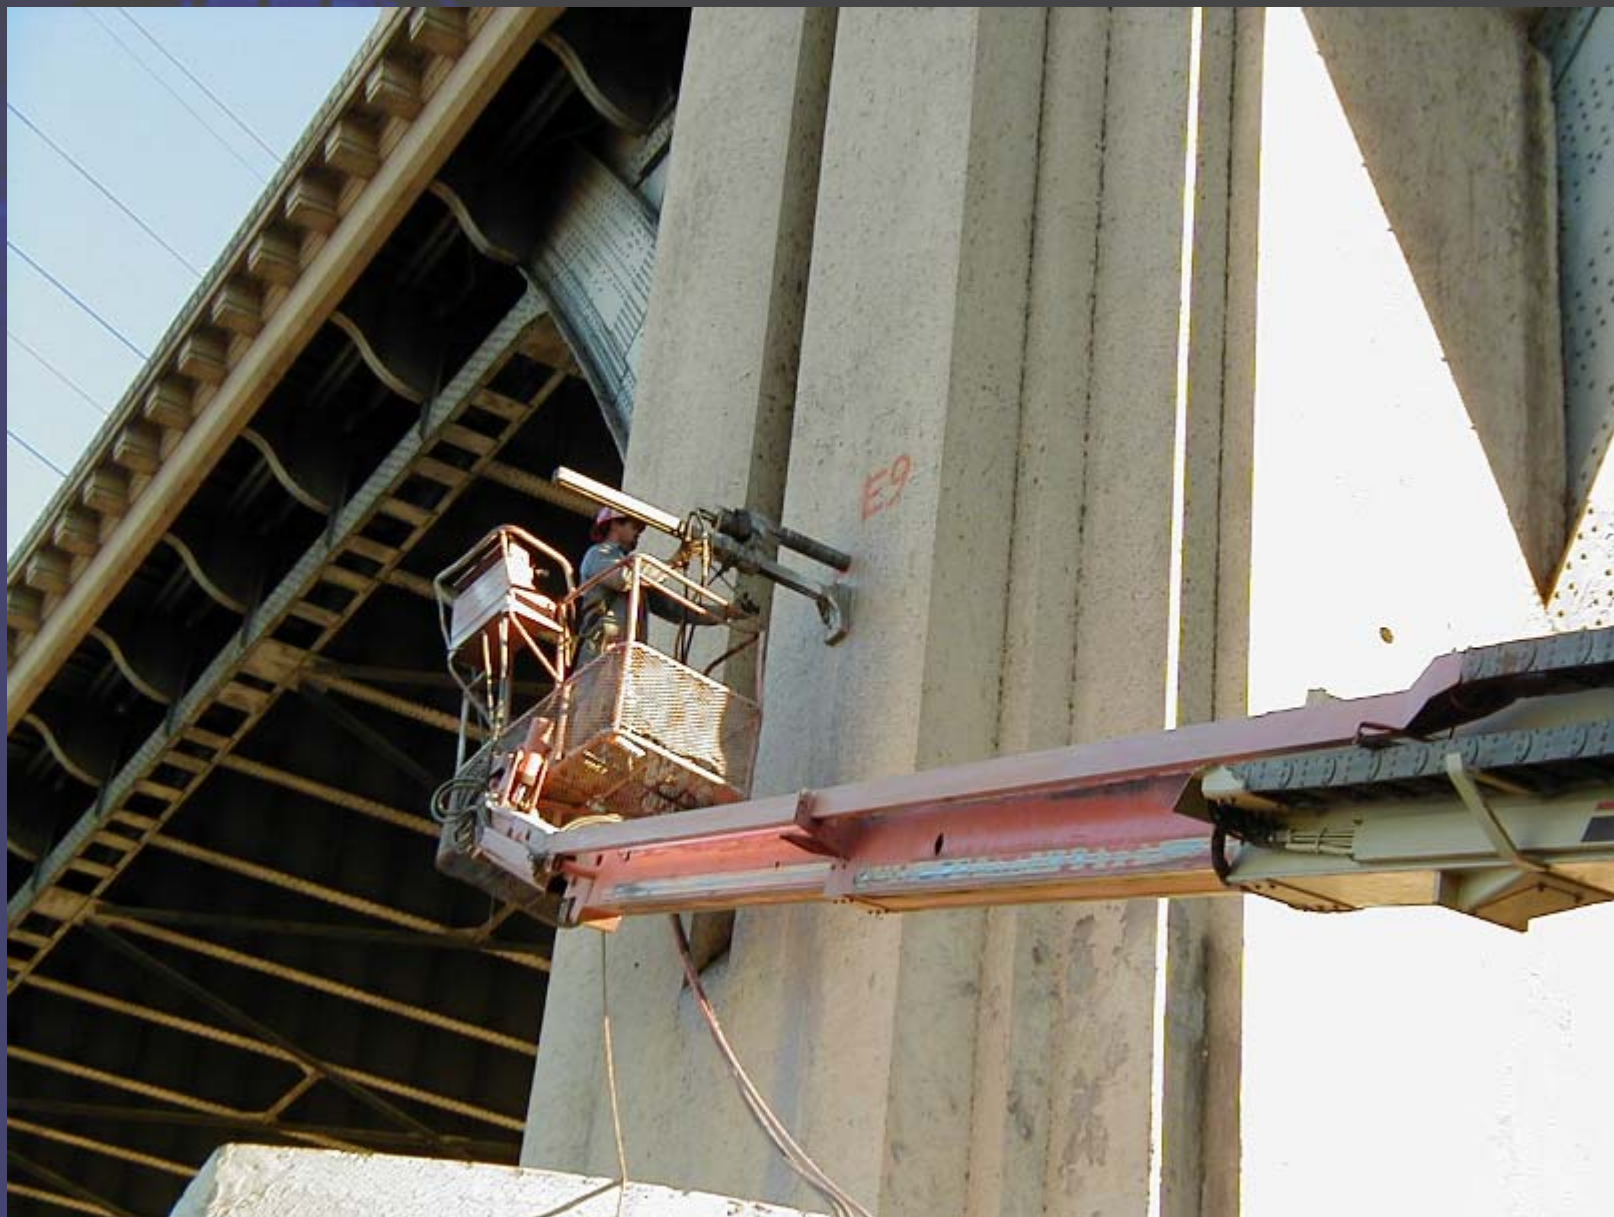
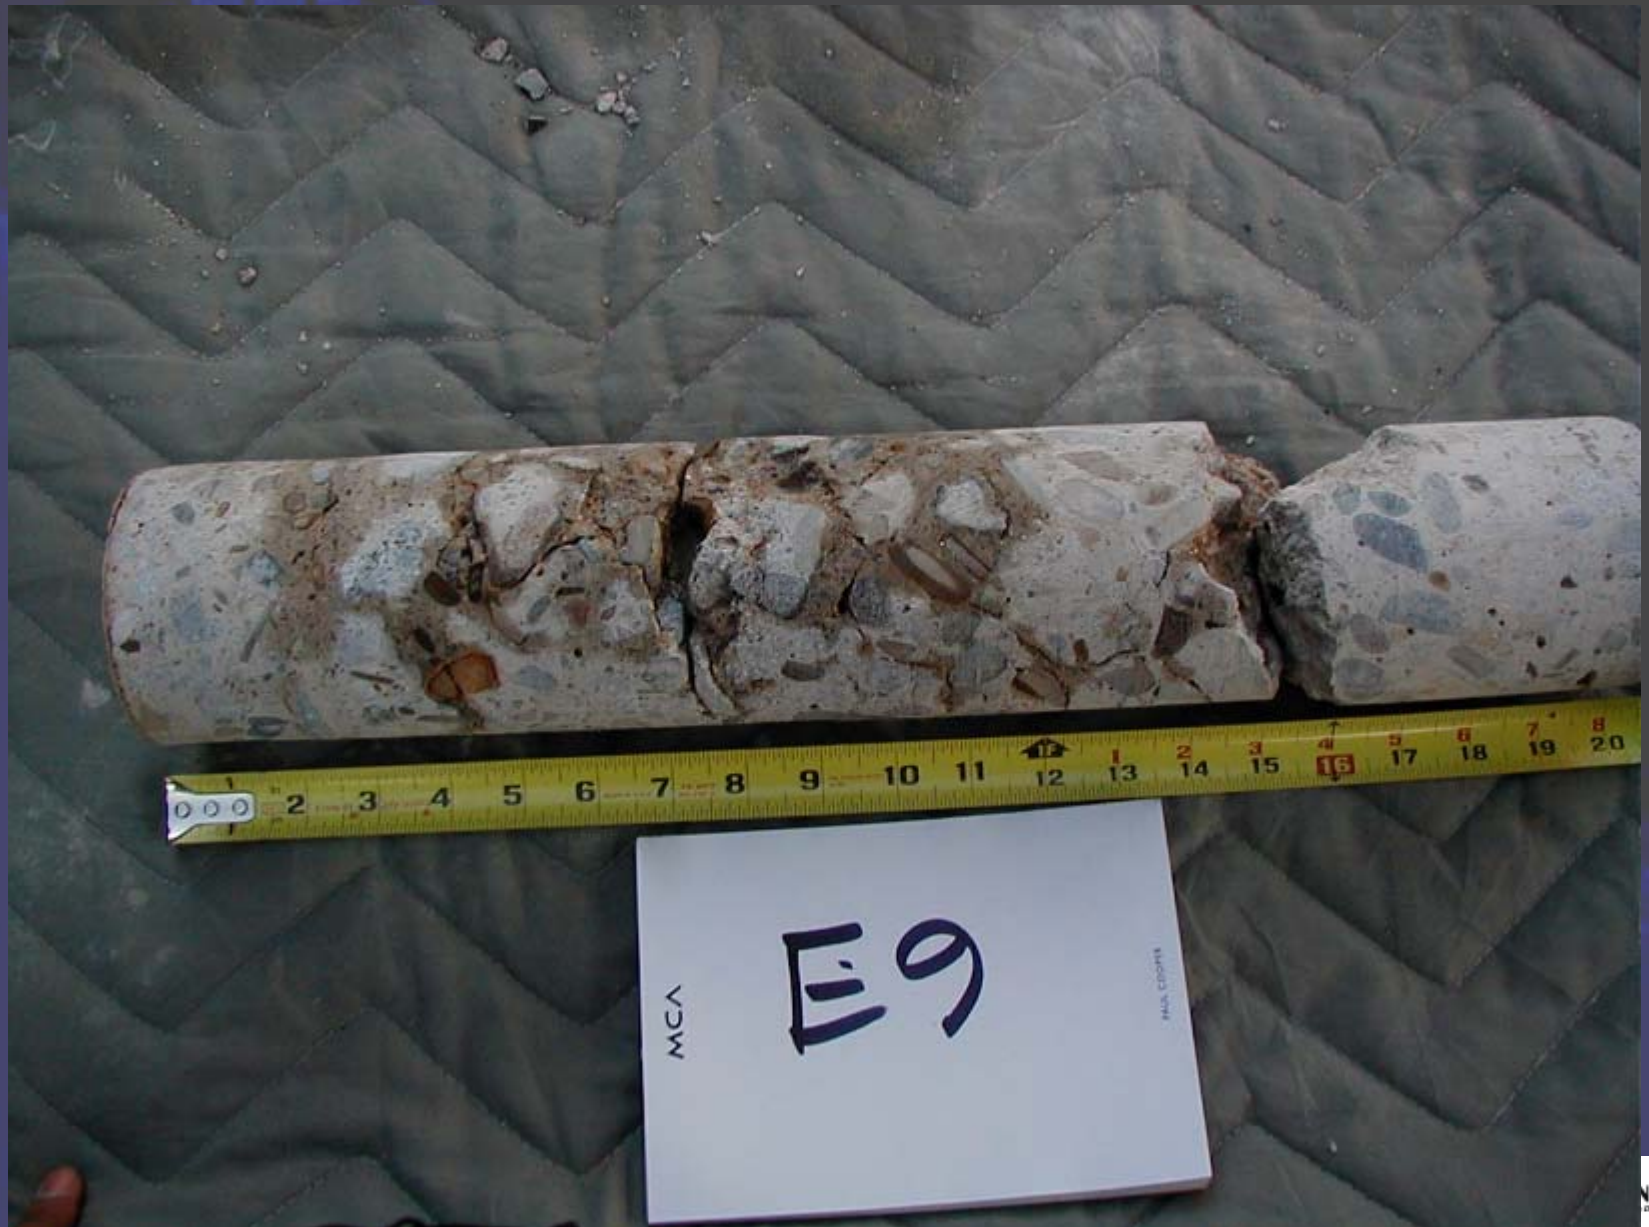
# Center River Pier, N. Pier

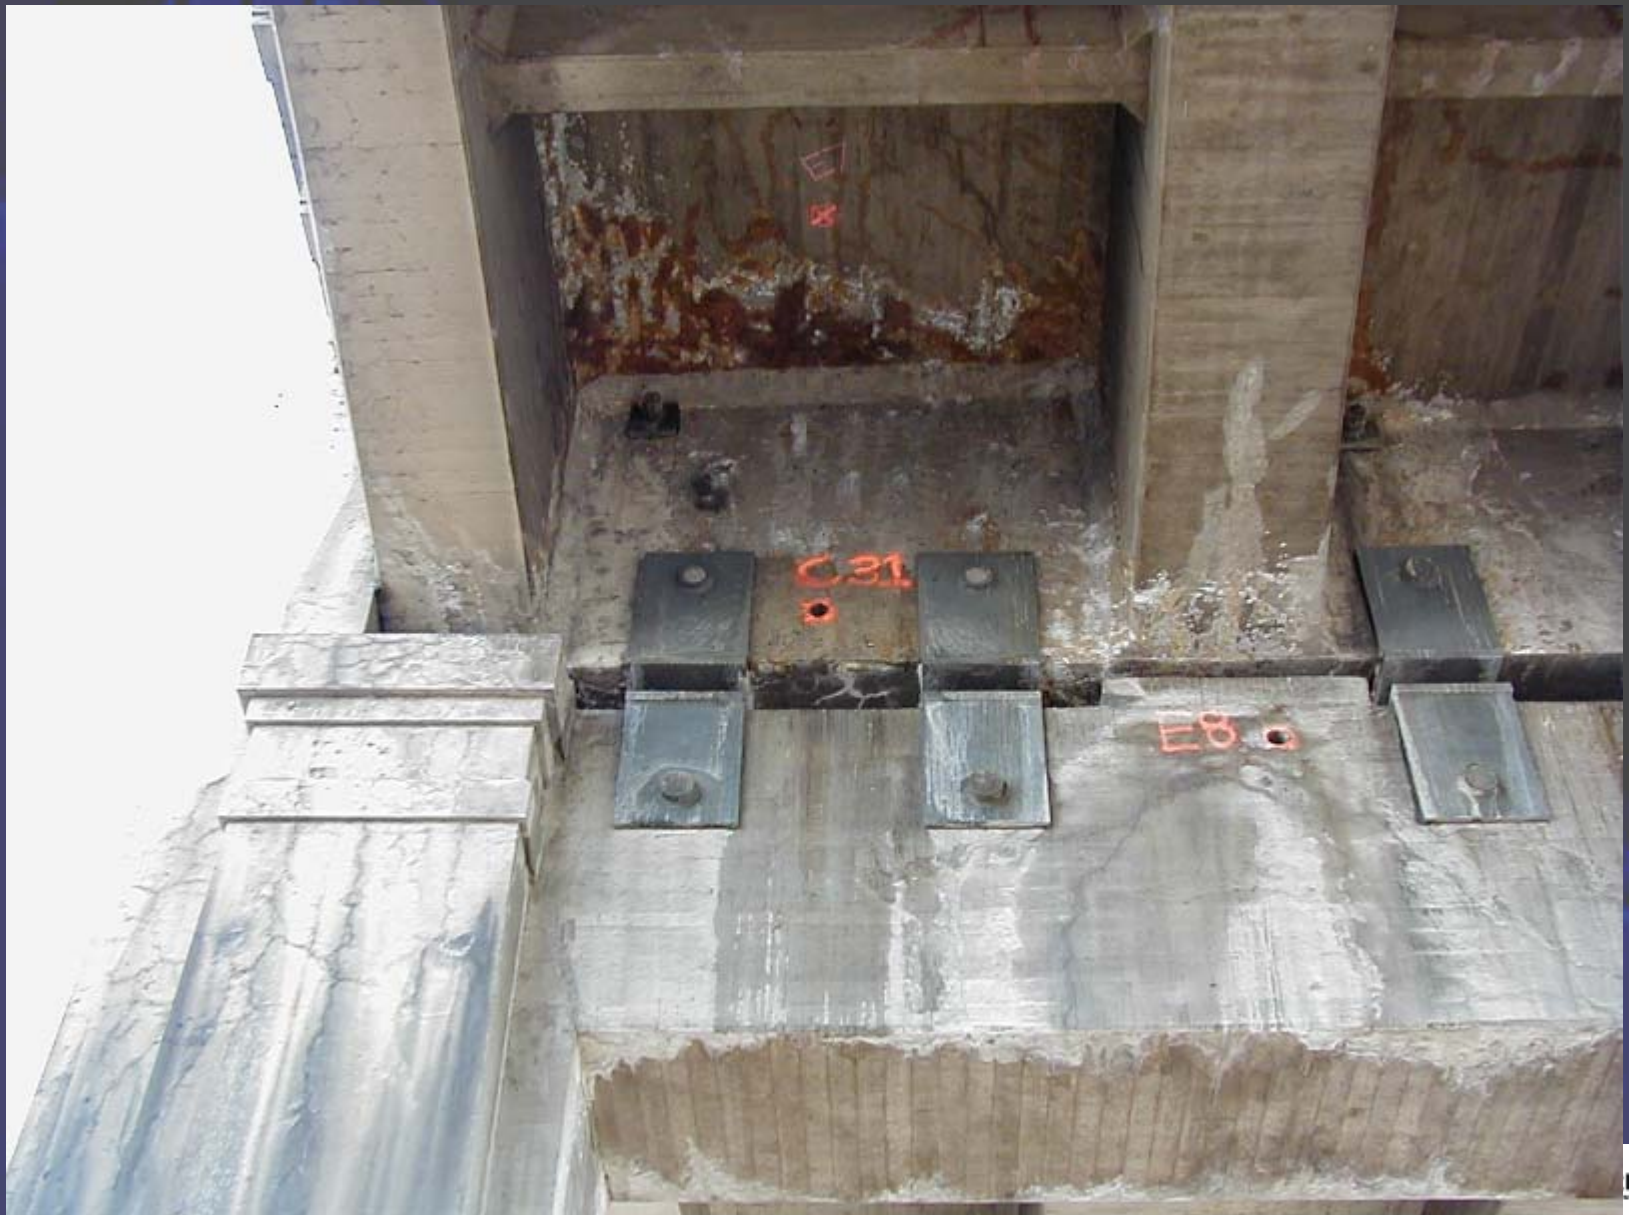
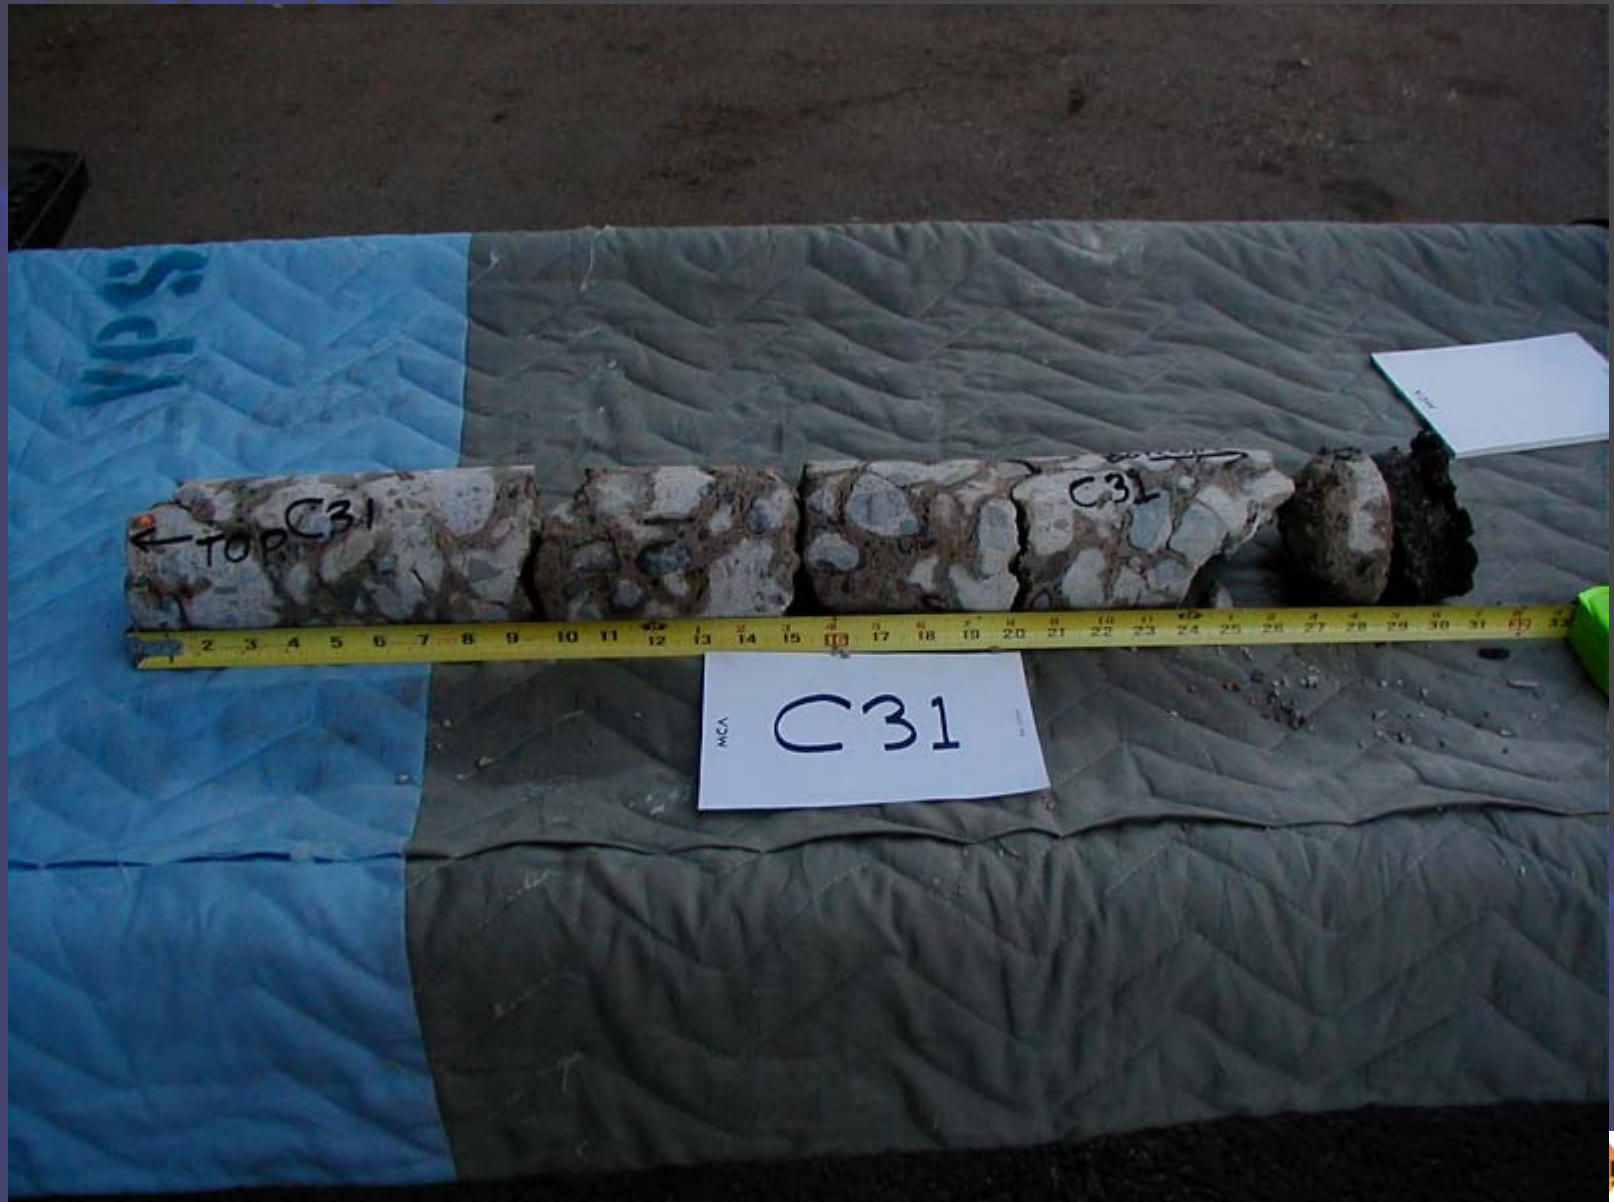
# Girder Distress, Bent 9

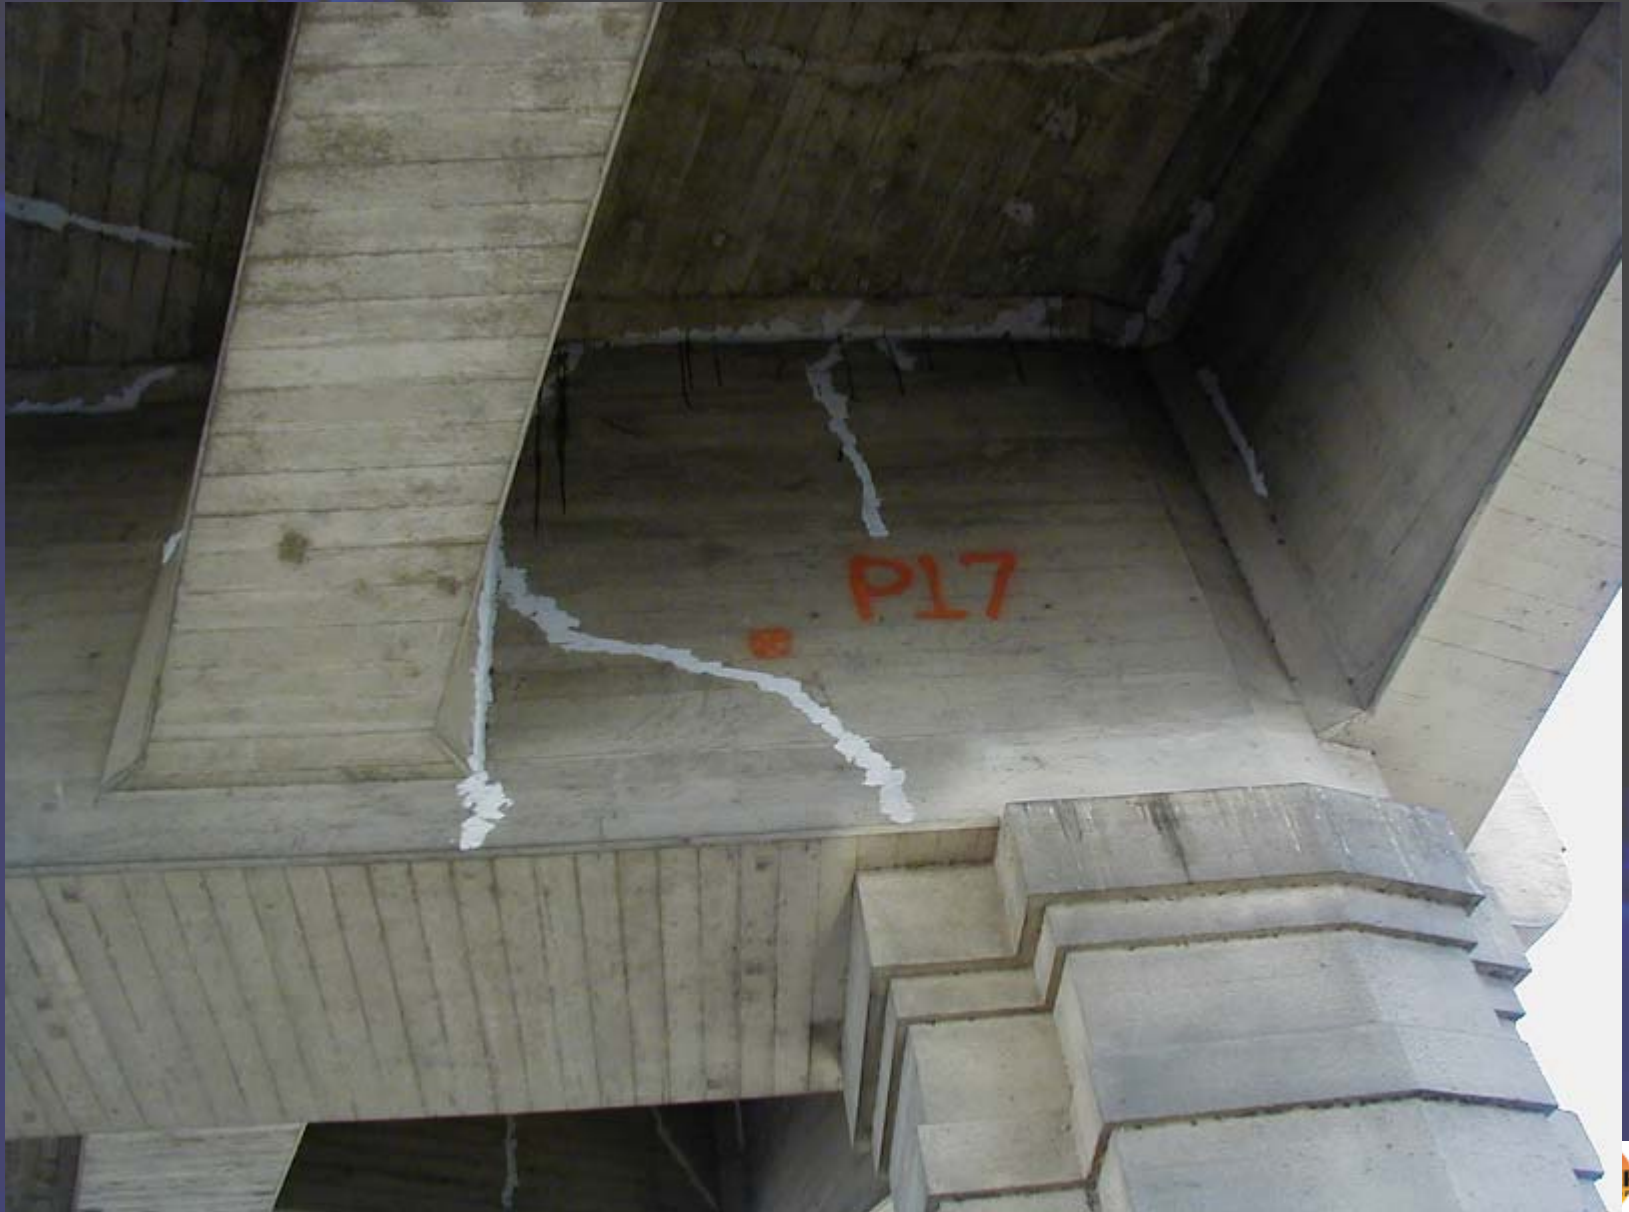
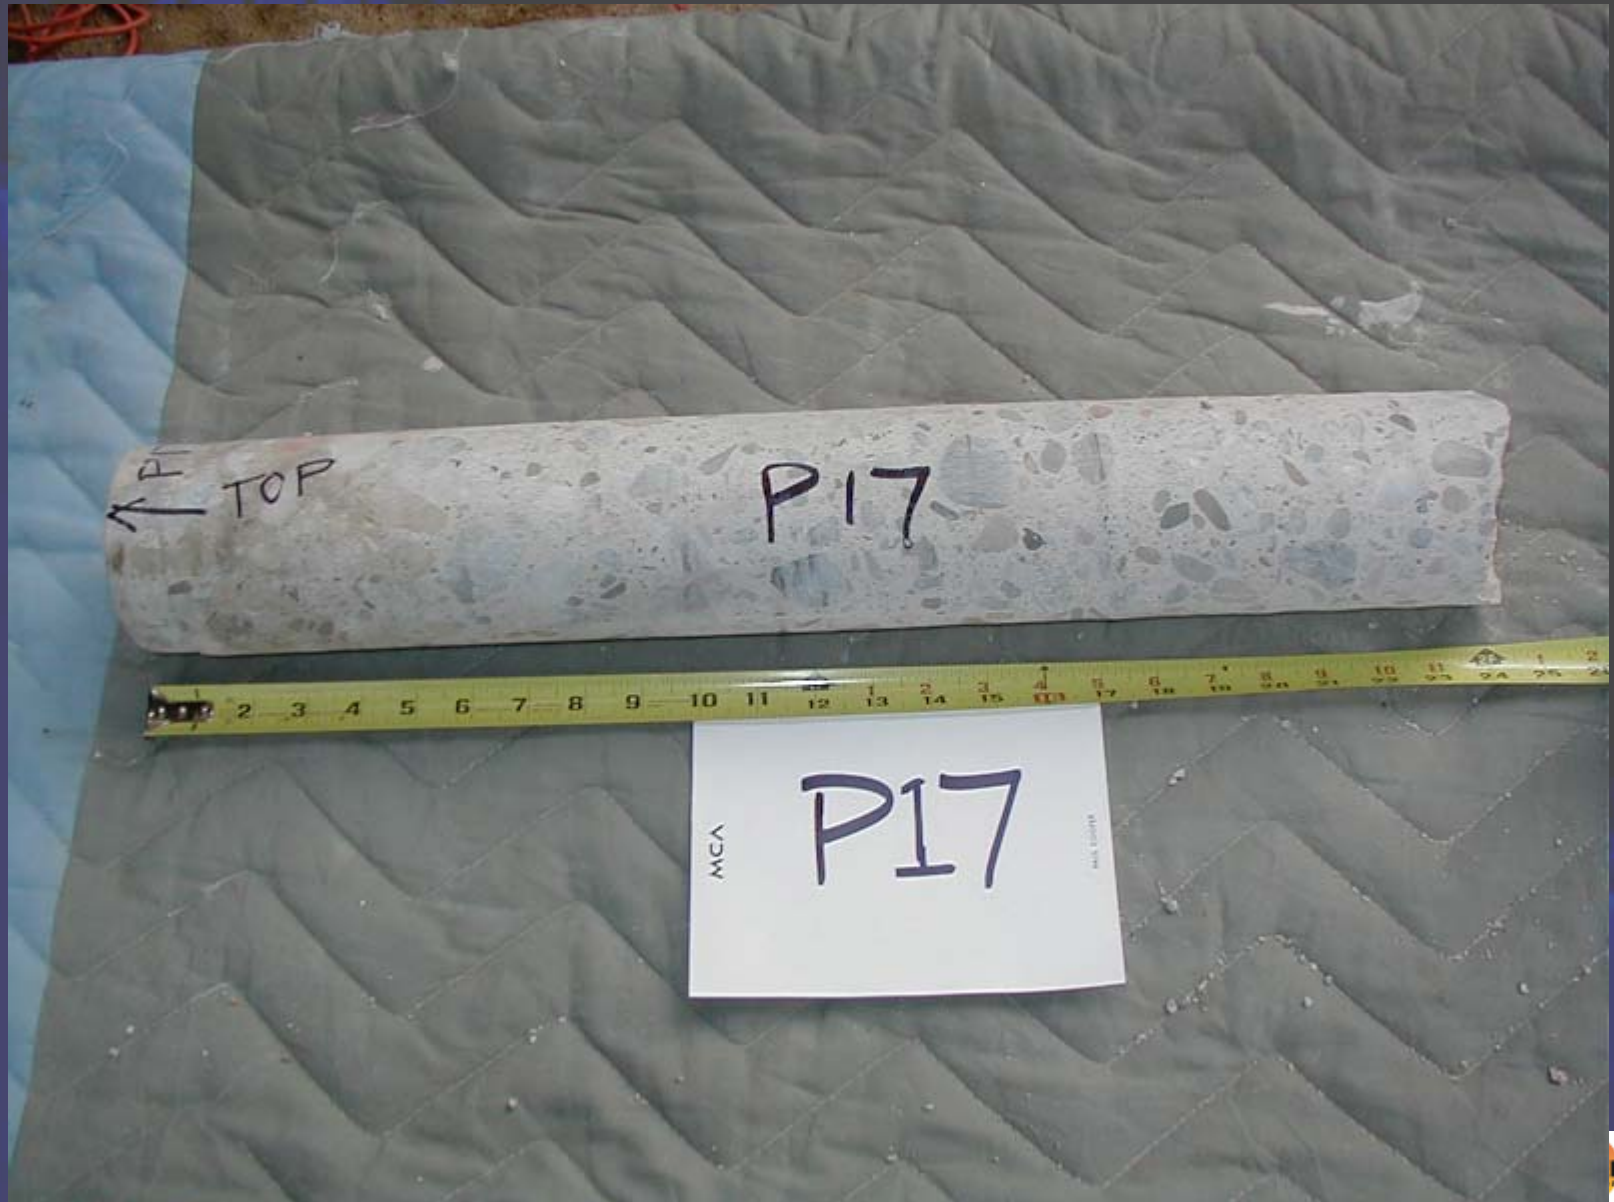
# Girder Distress, Bent 25

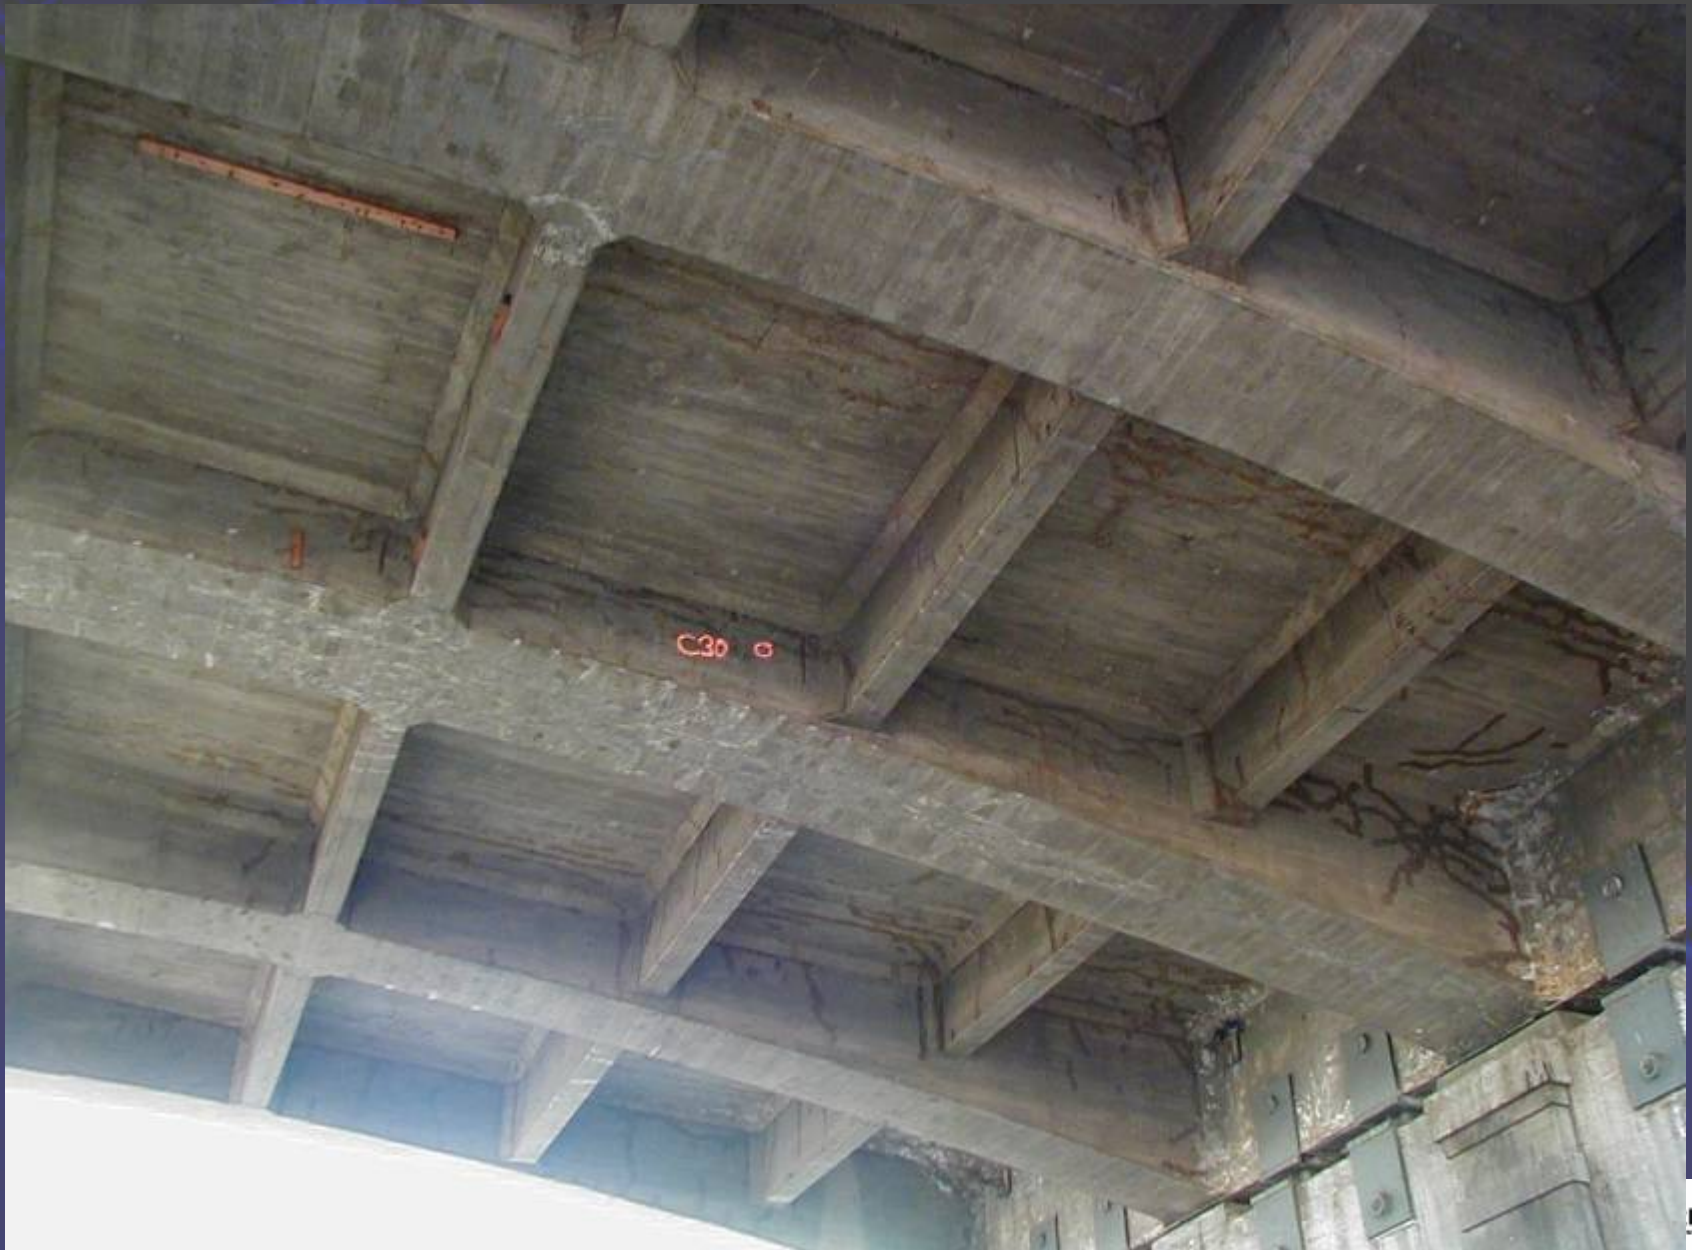
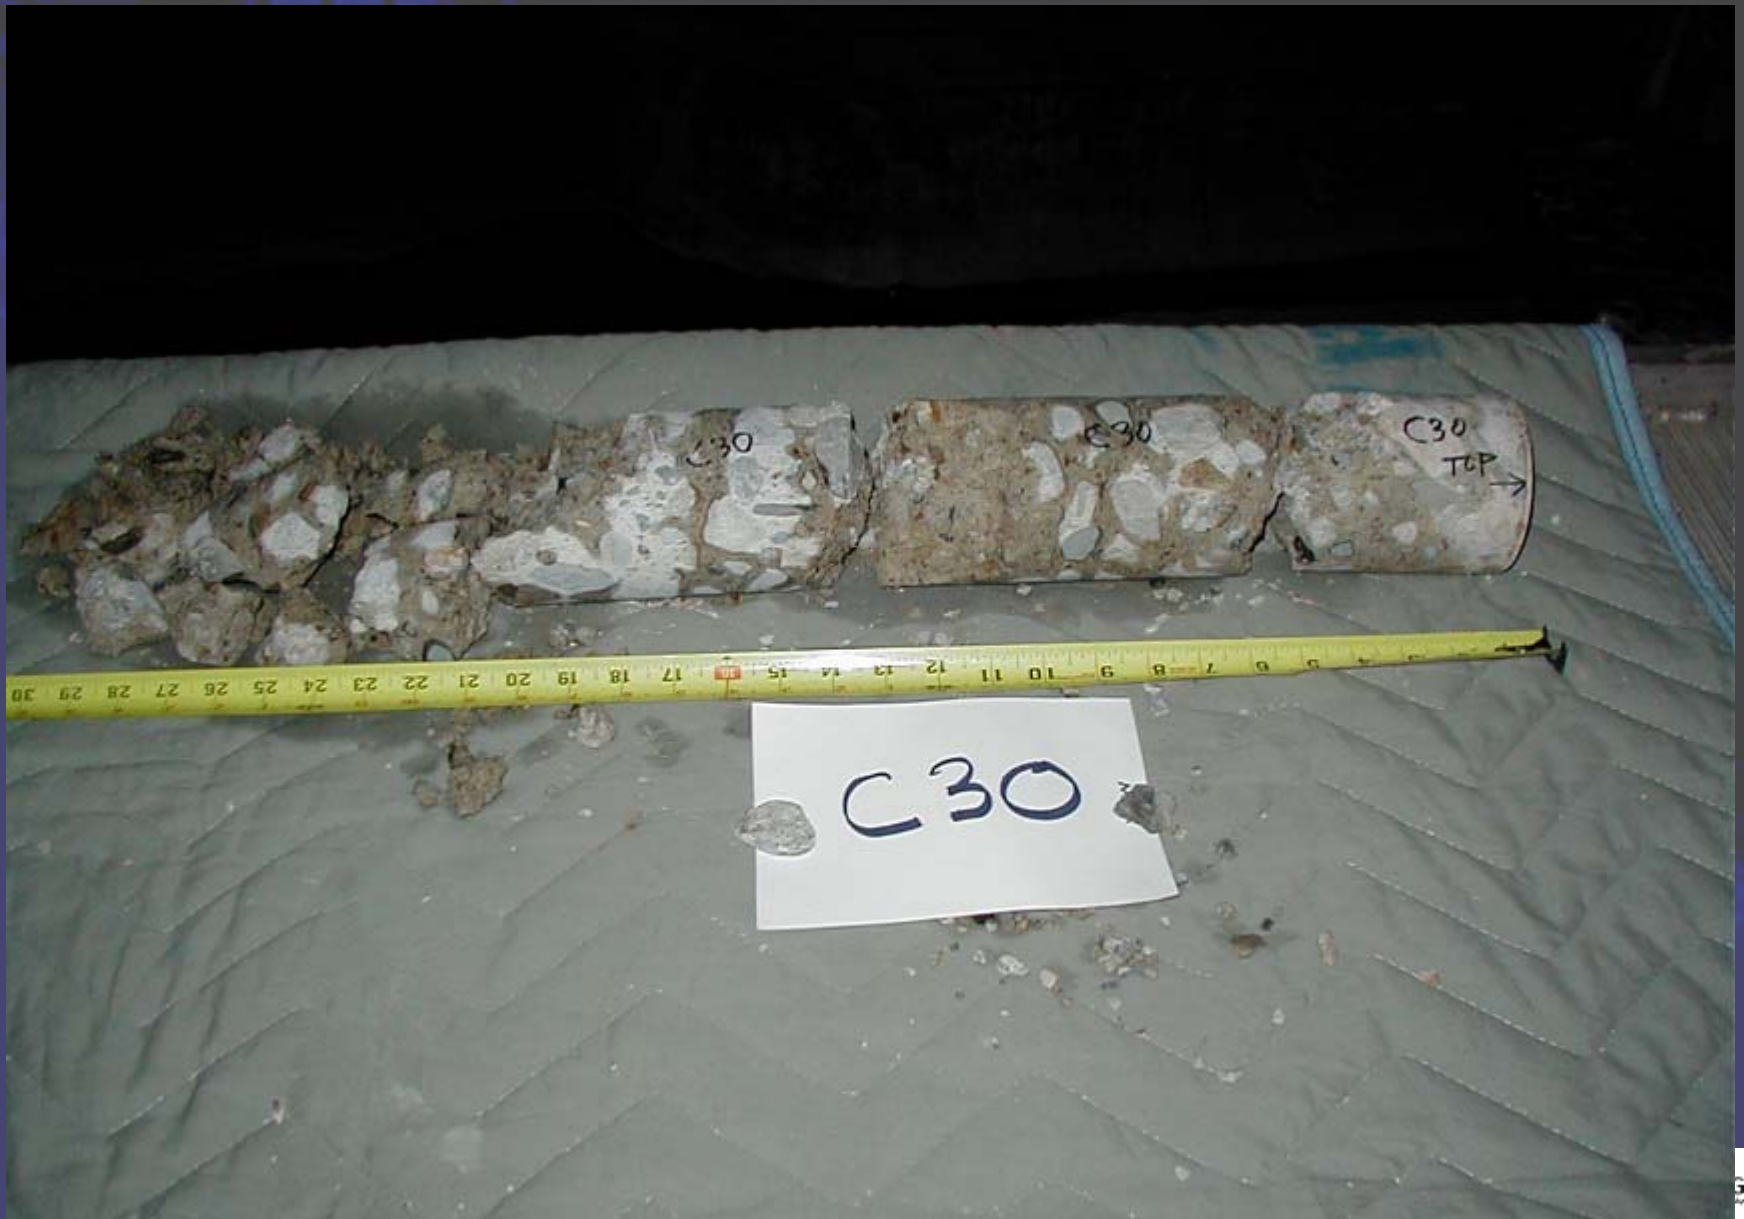
# Girder Distress, Grid 6.4

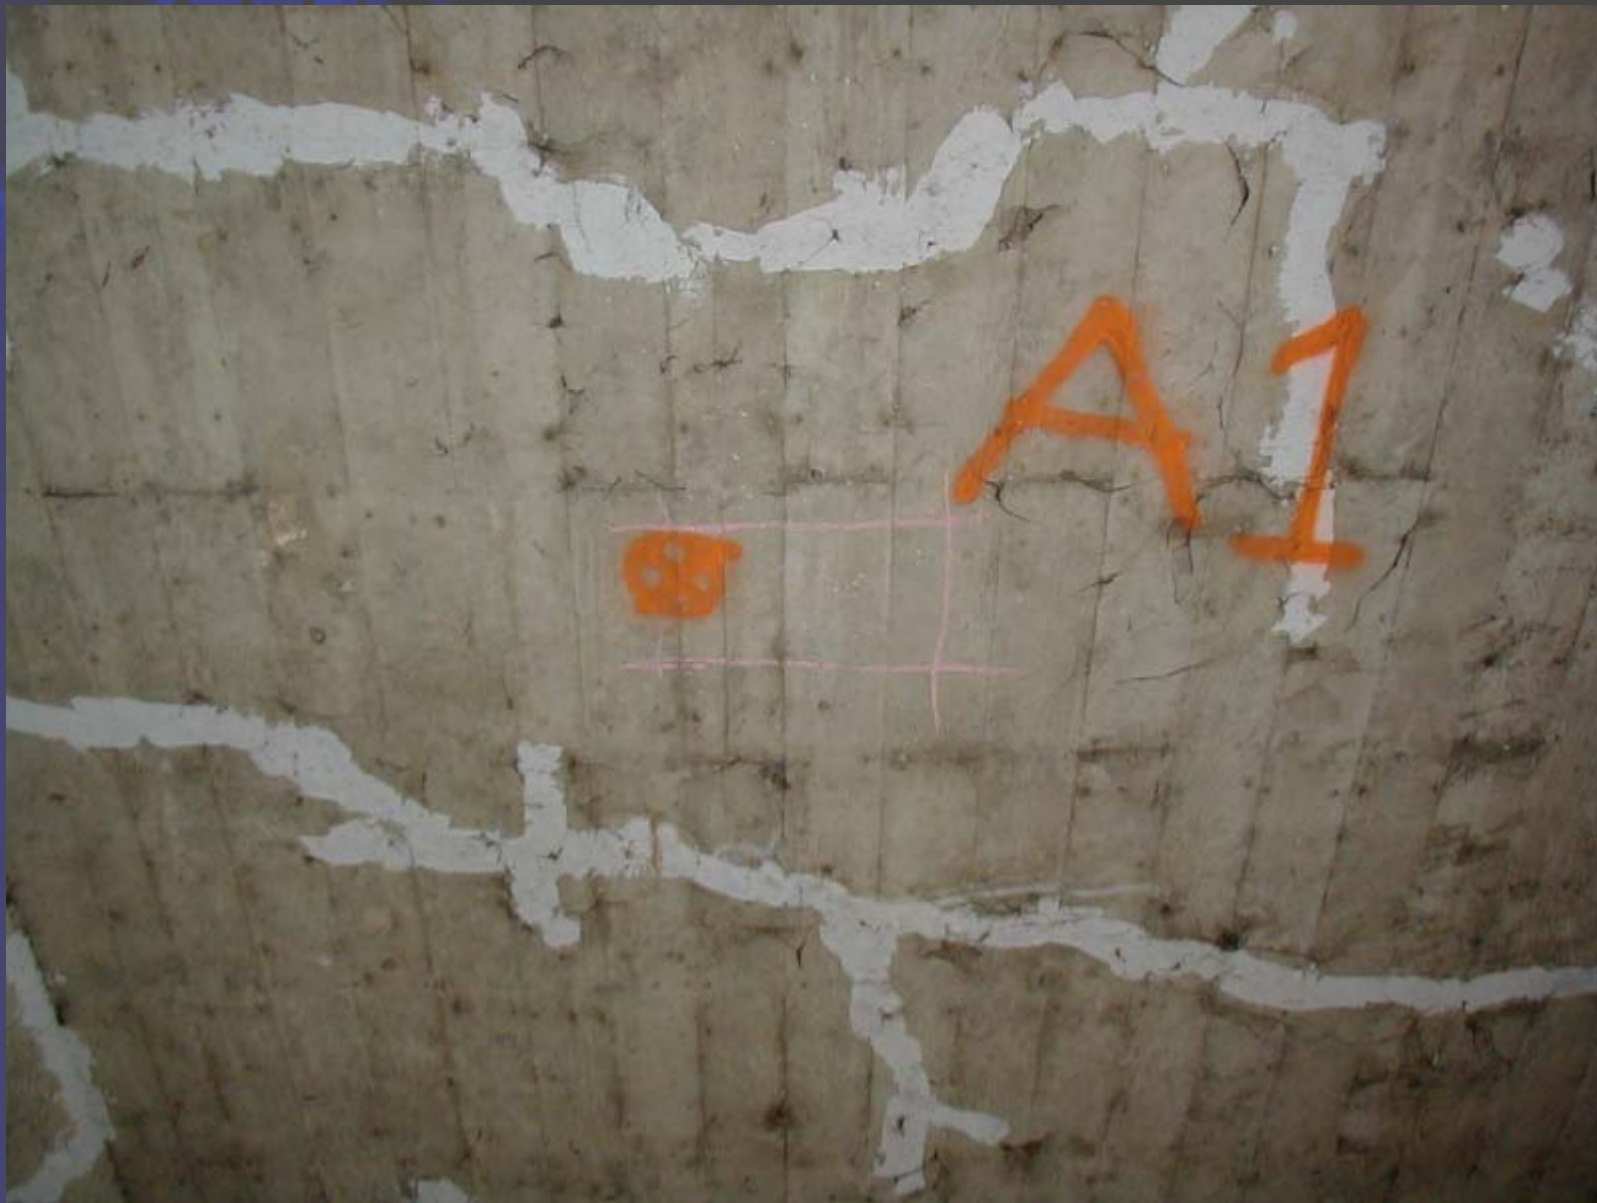
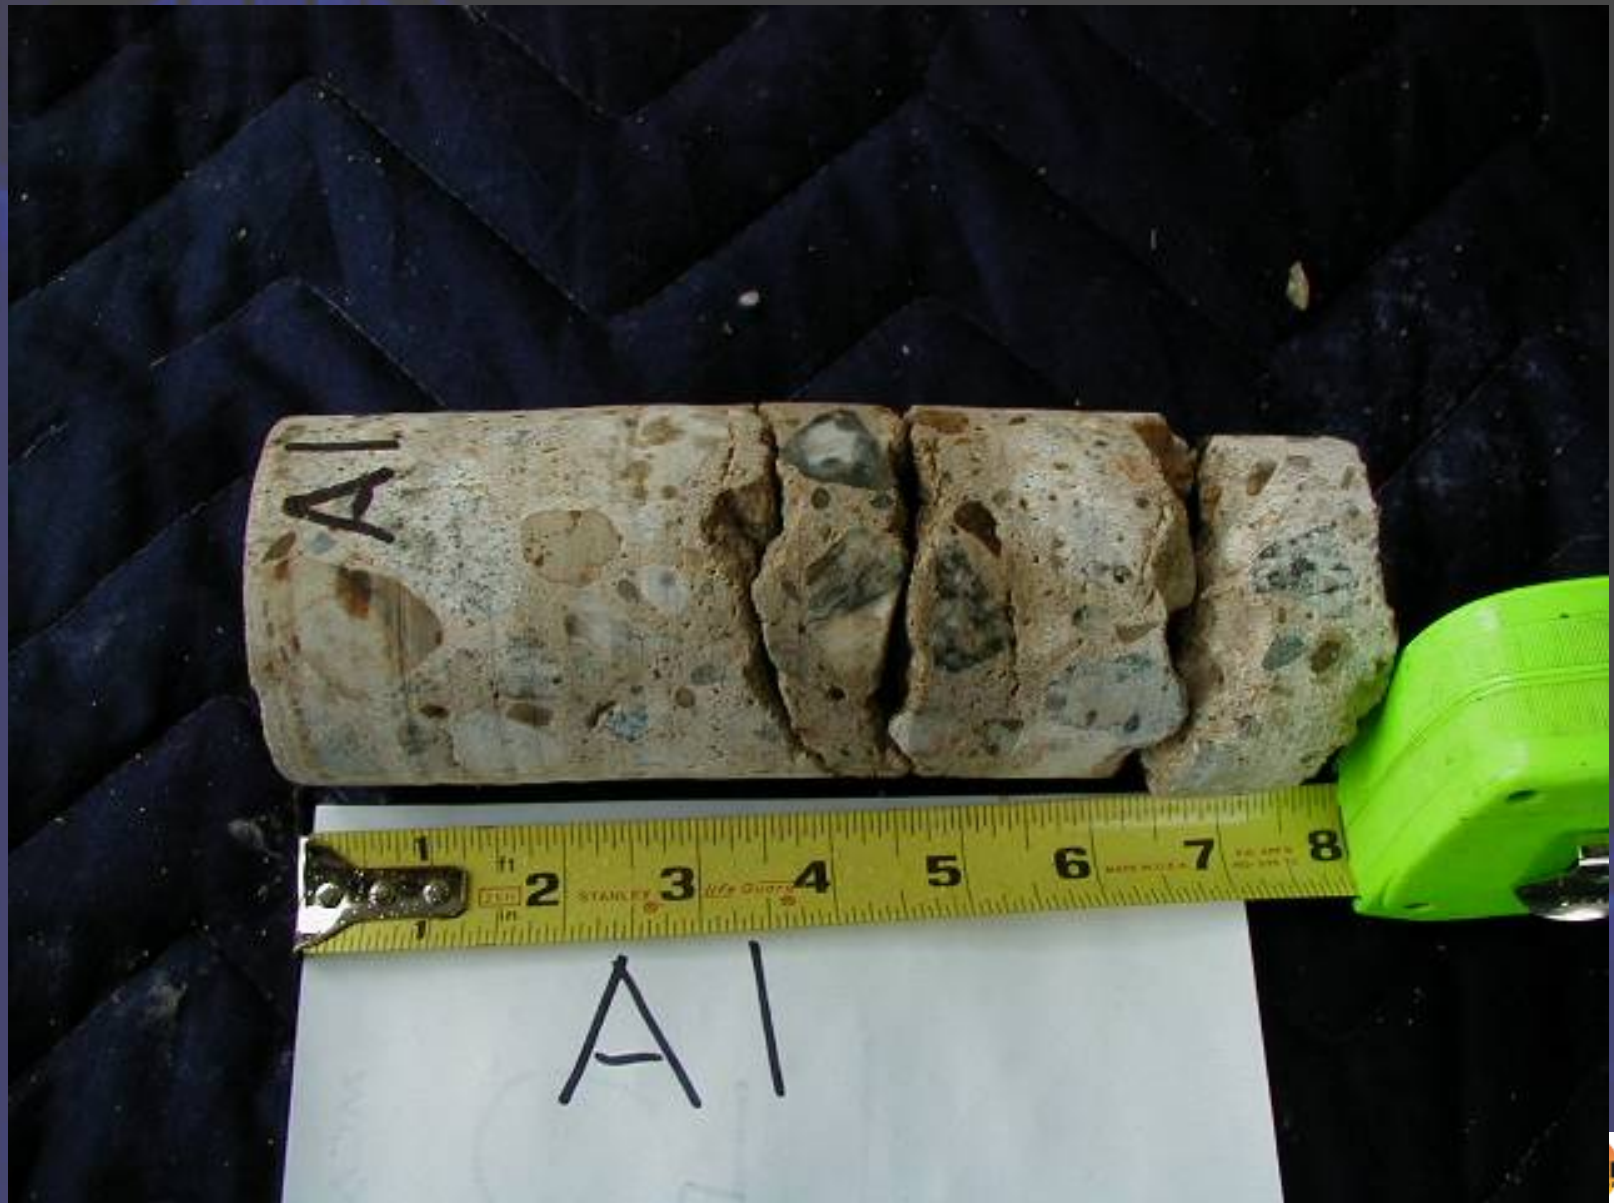
# Deck Distress, Grid 28.2
