# Sixth Street Viaduct Seismic Improvement Program Alkali Silica Reaction Workshop 8/27/08

# Alkali Silica Reaction (ASR) Material Finding at the Sixth Street Viaduct

# Visual Condition Survey

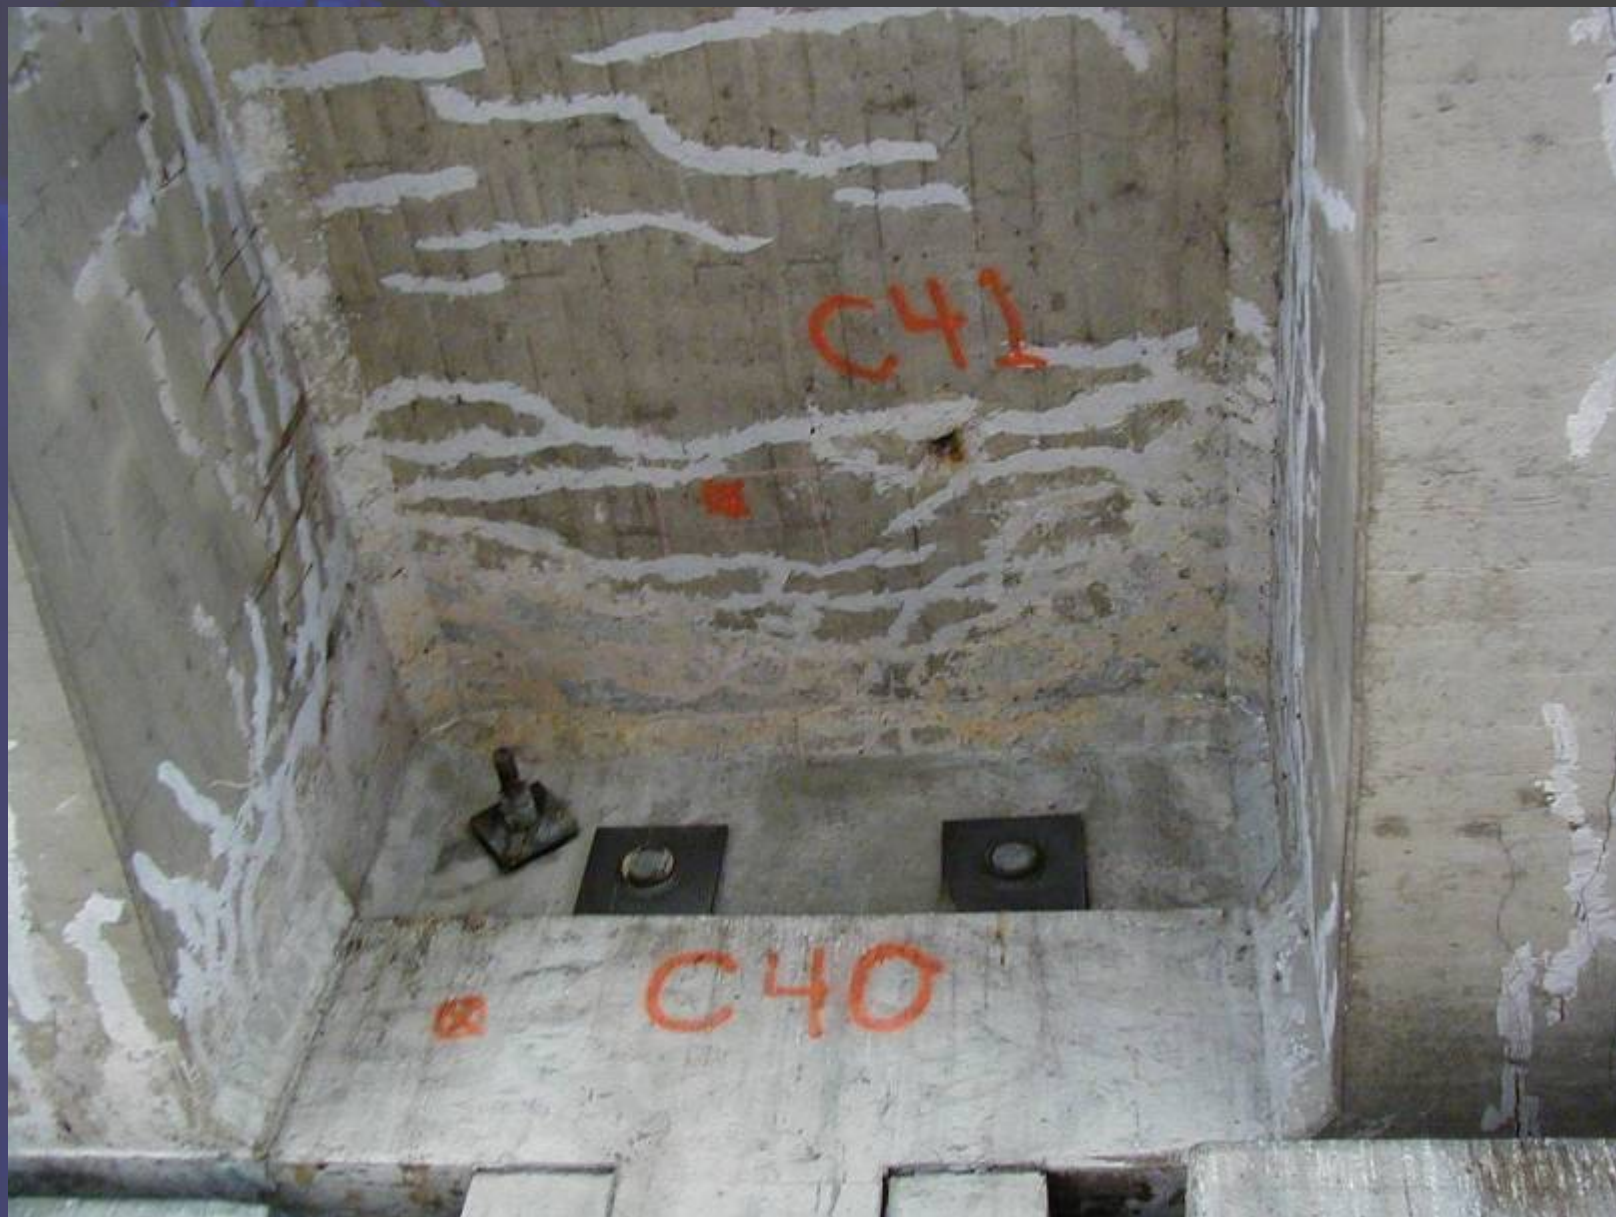
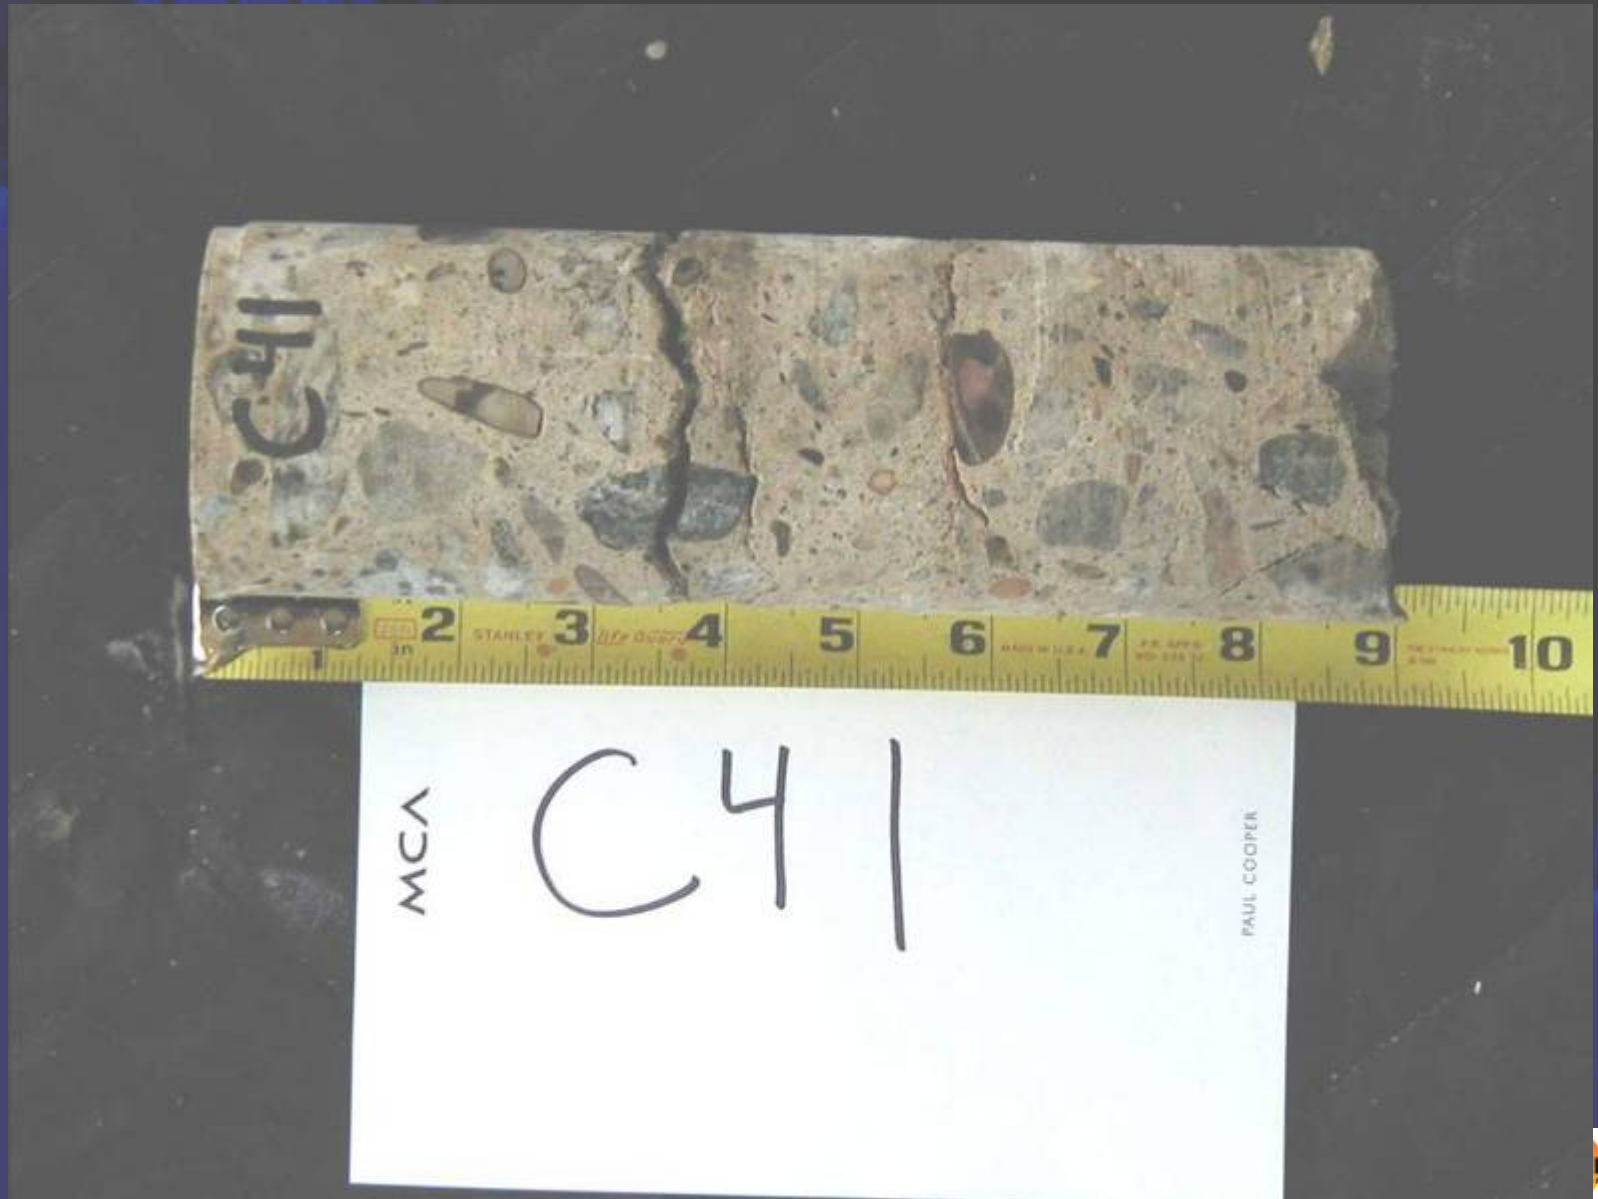
# Deck Distress, Grid 28.8

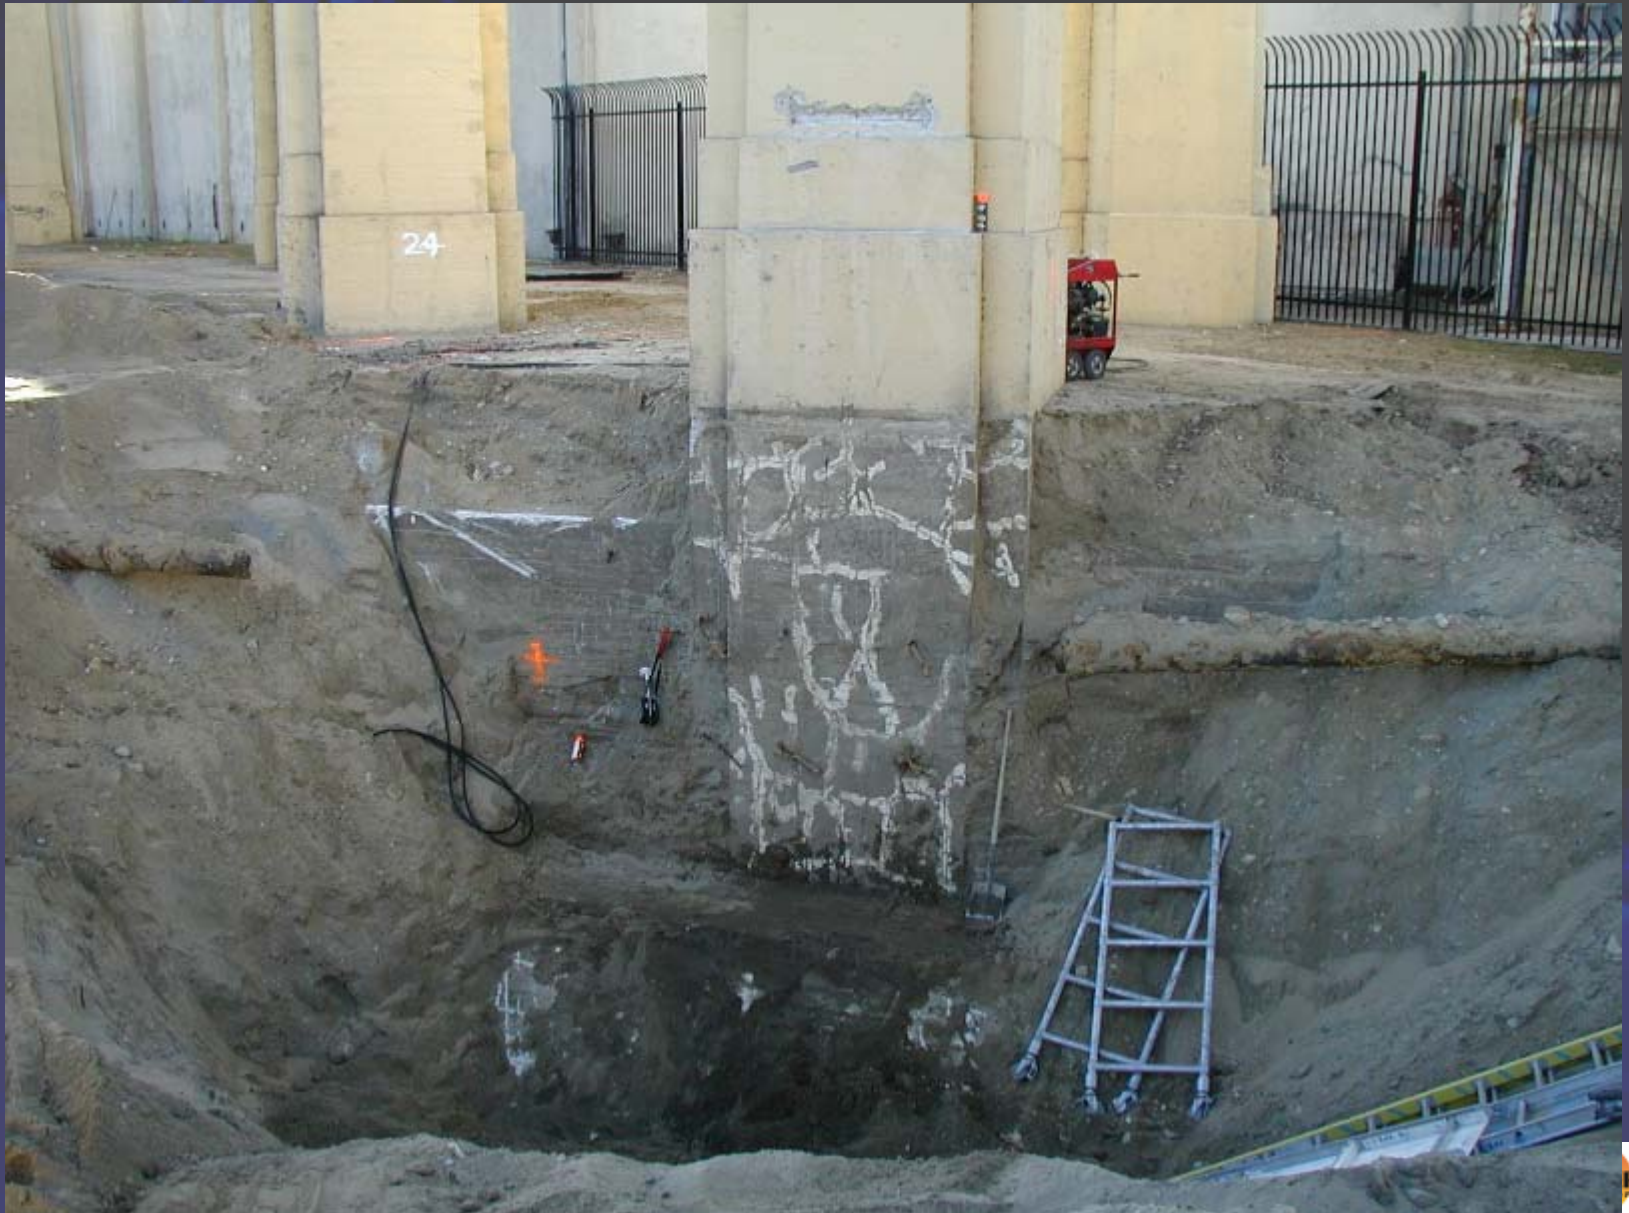
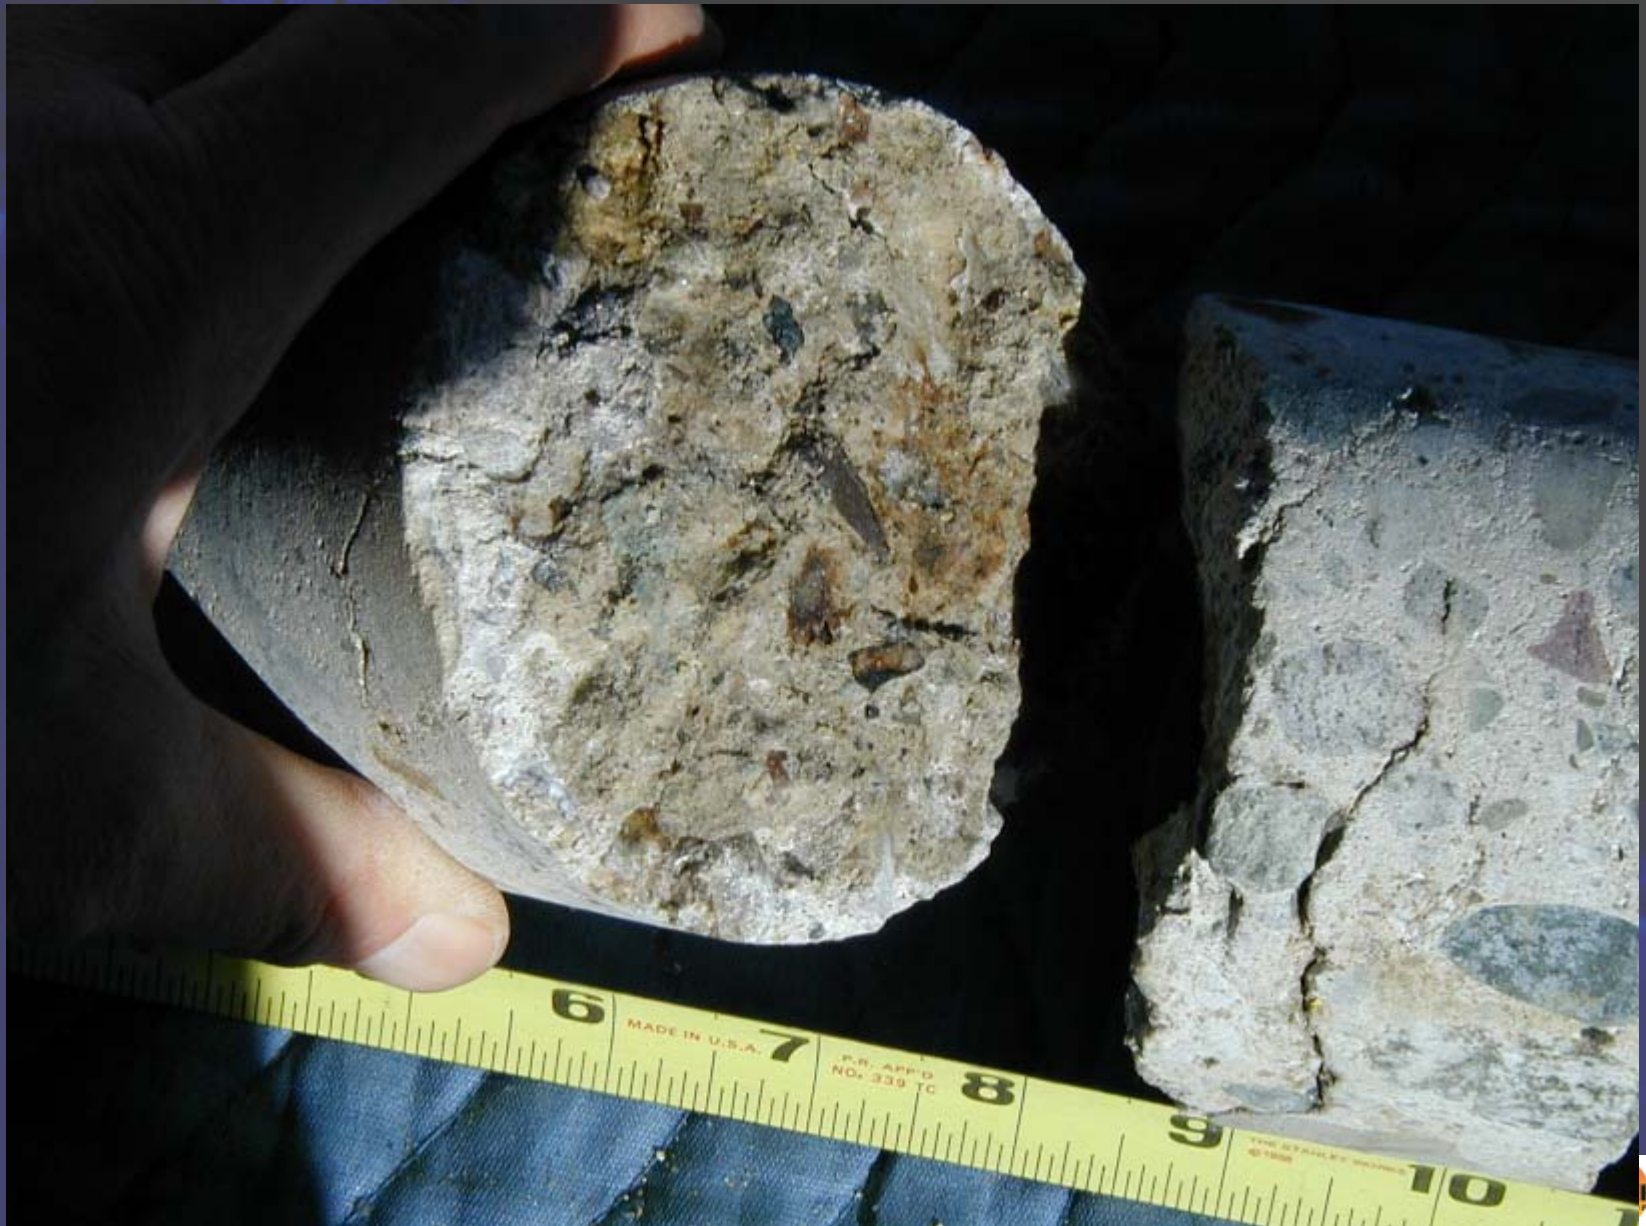
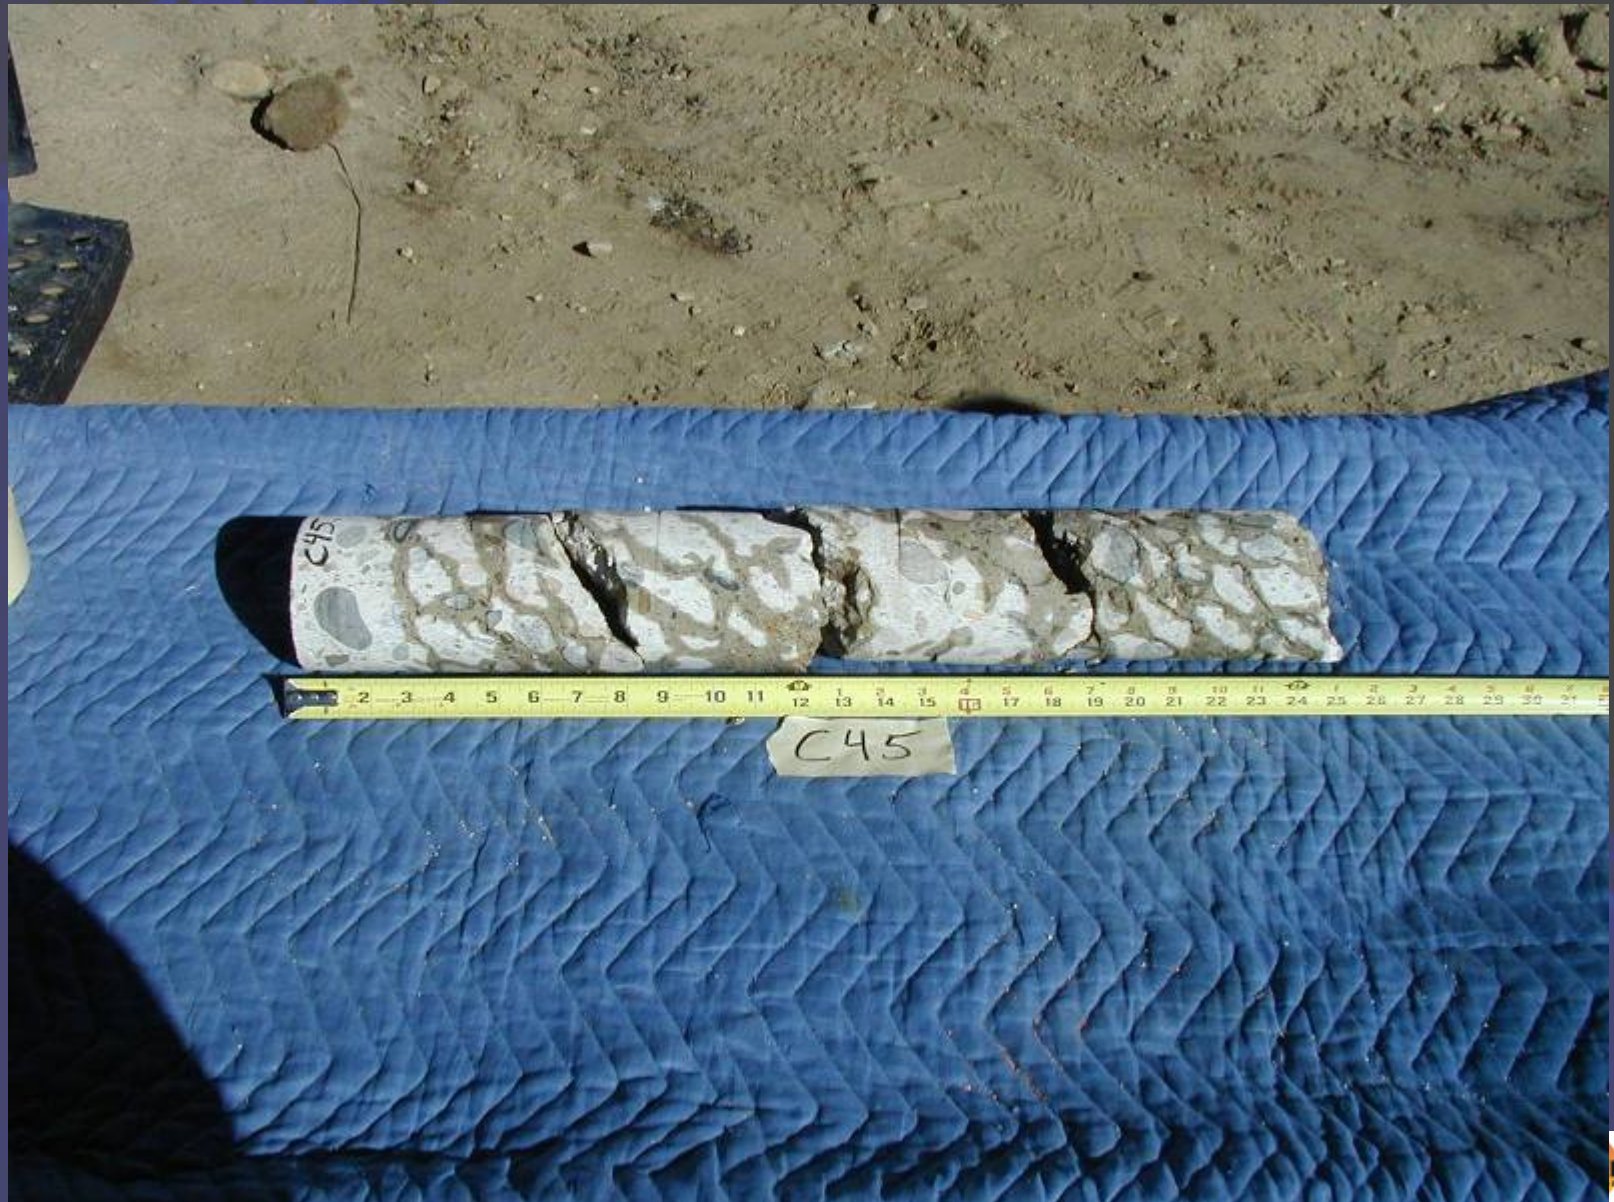
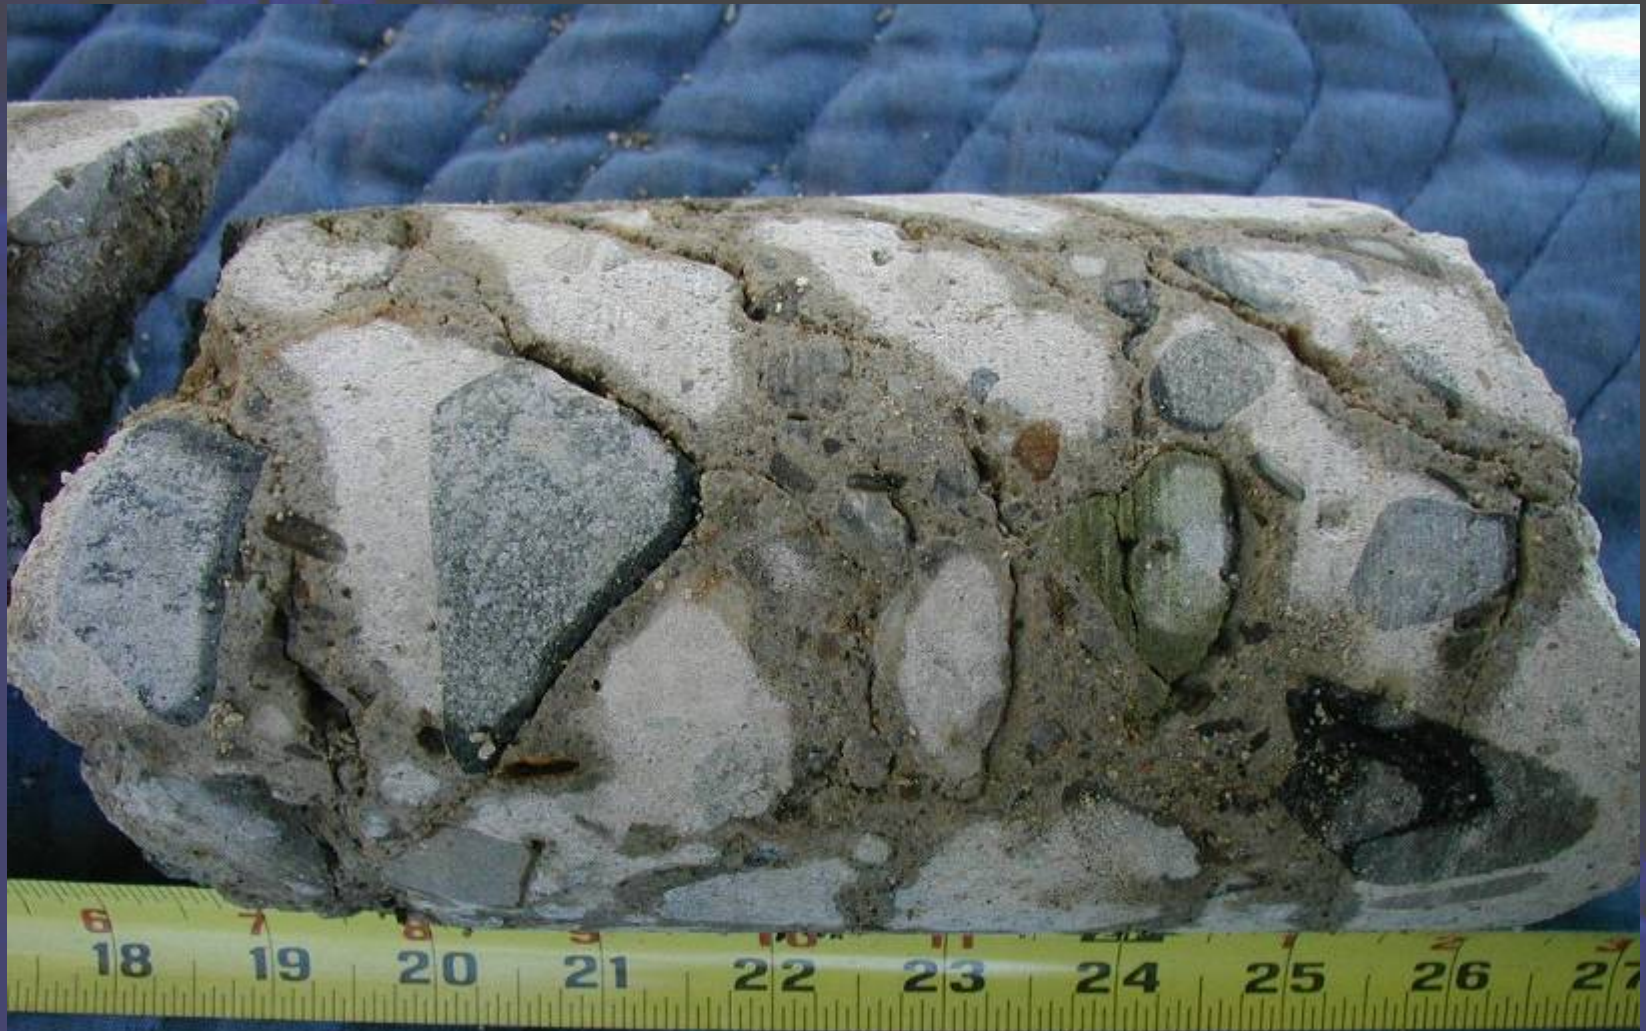
# Foundation Distress, Bent 23

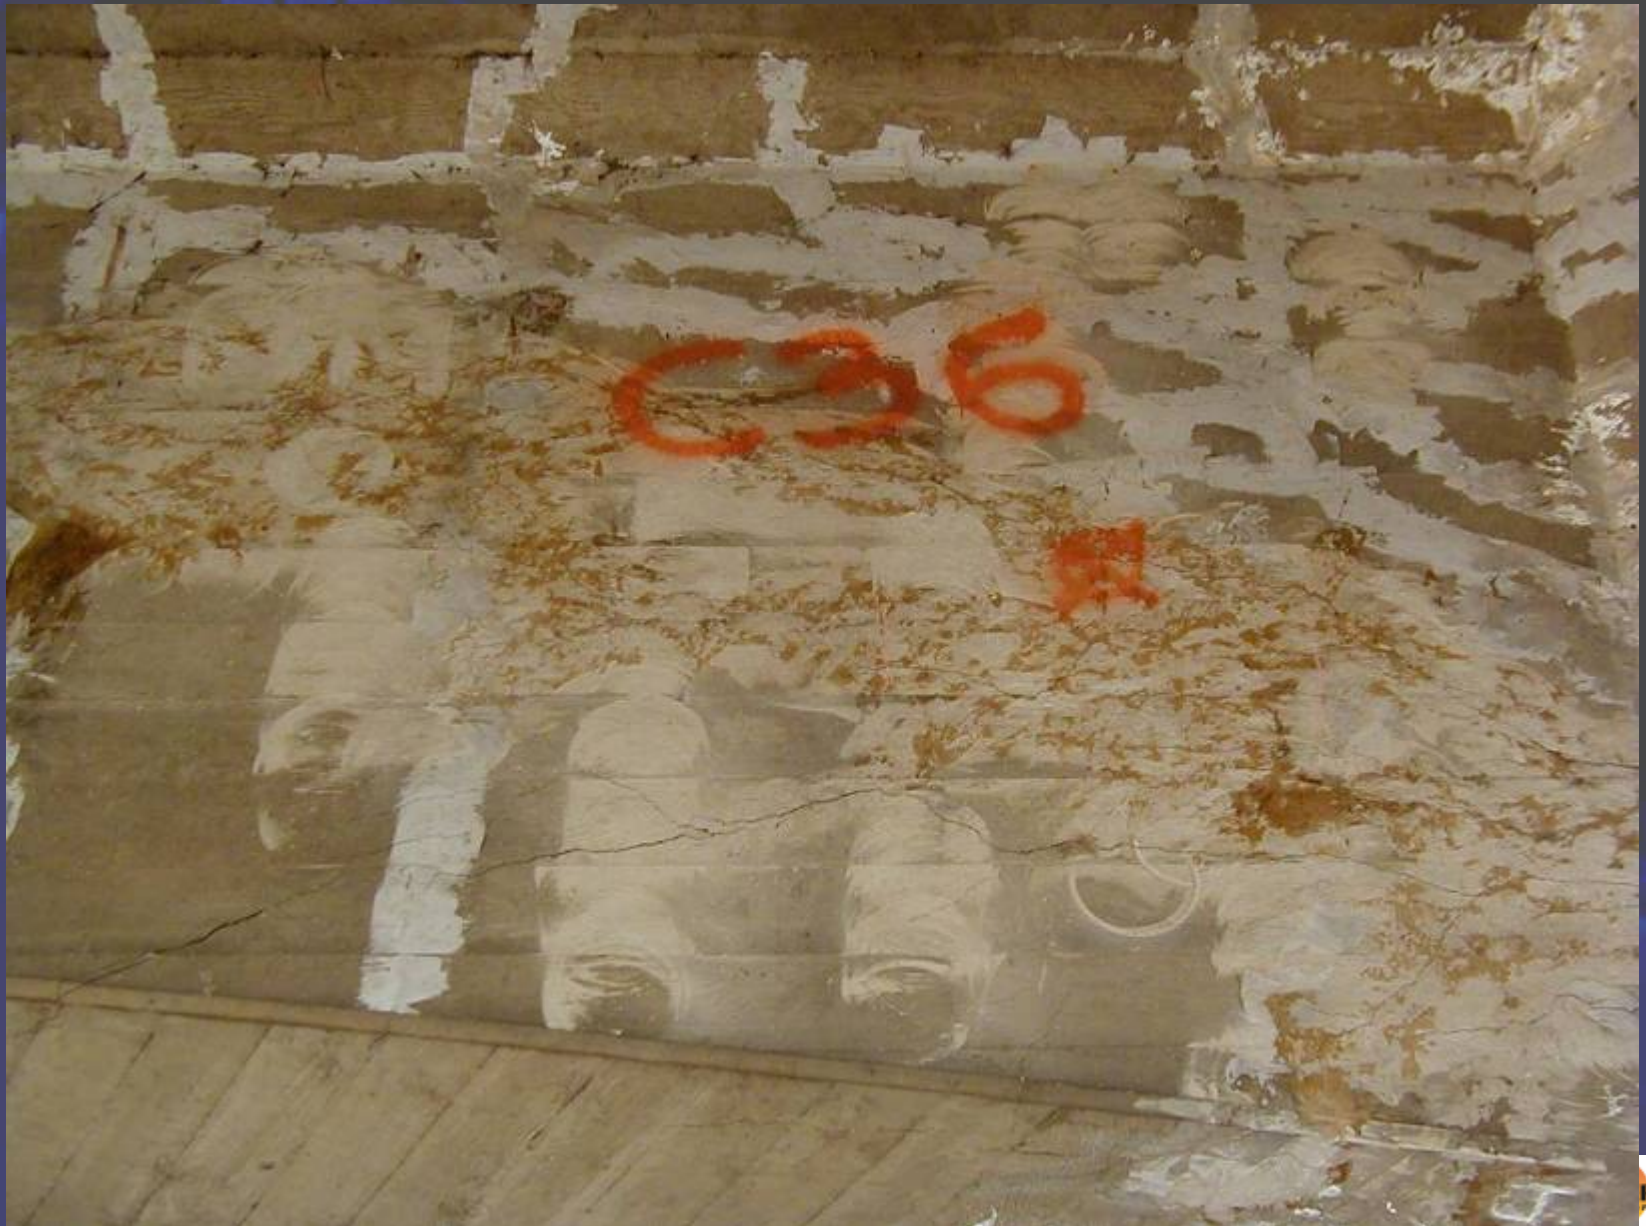
# New Cracking Occurring

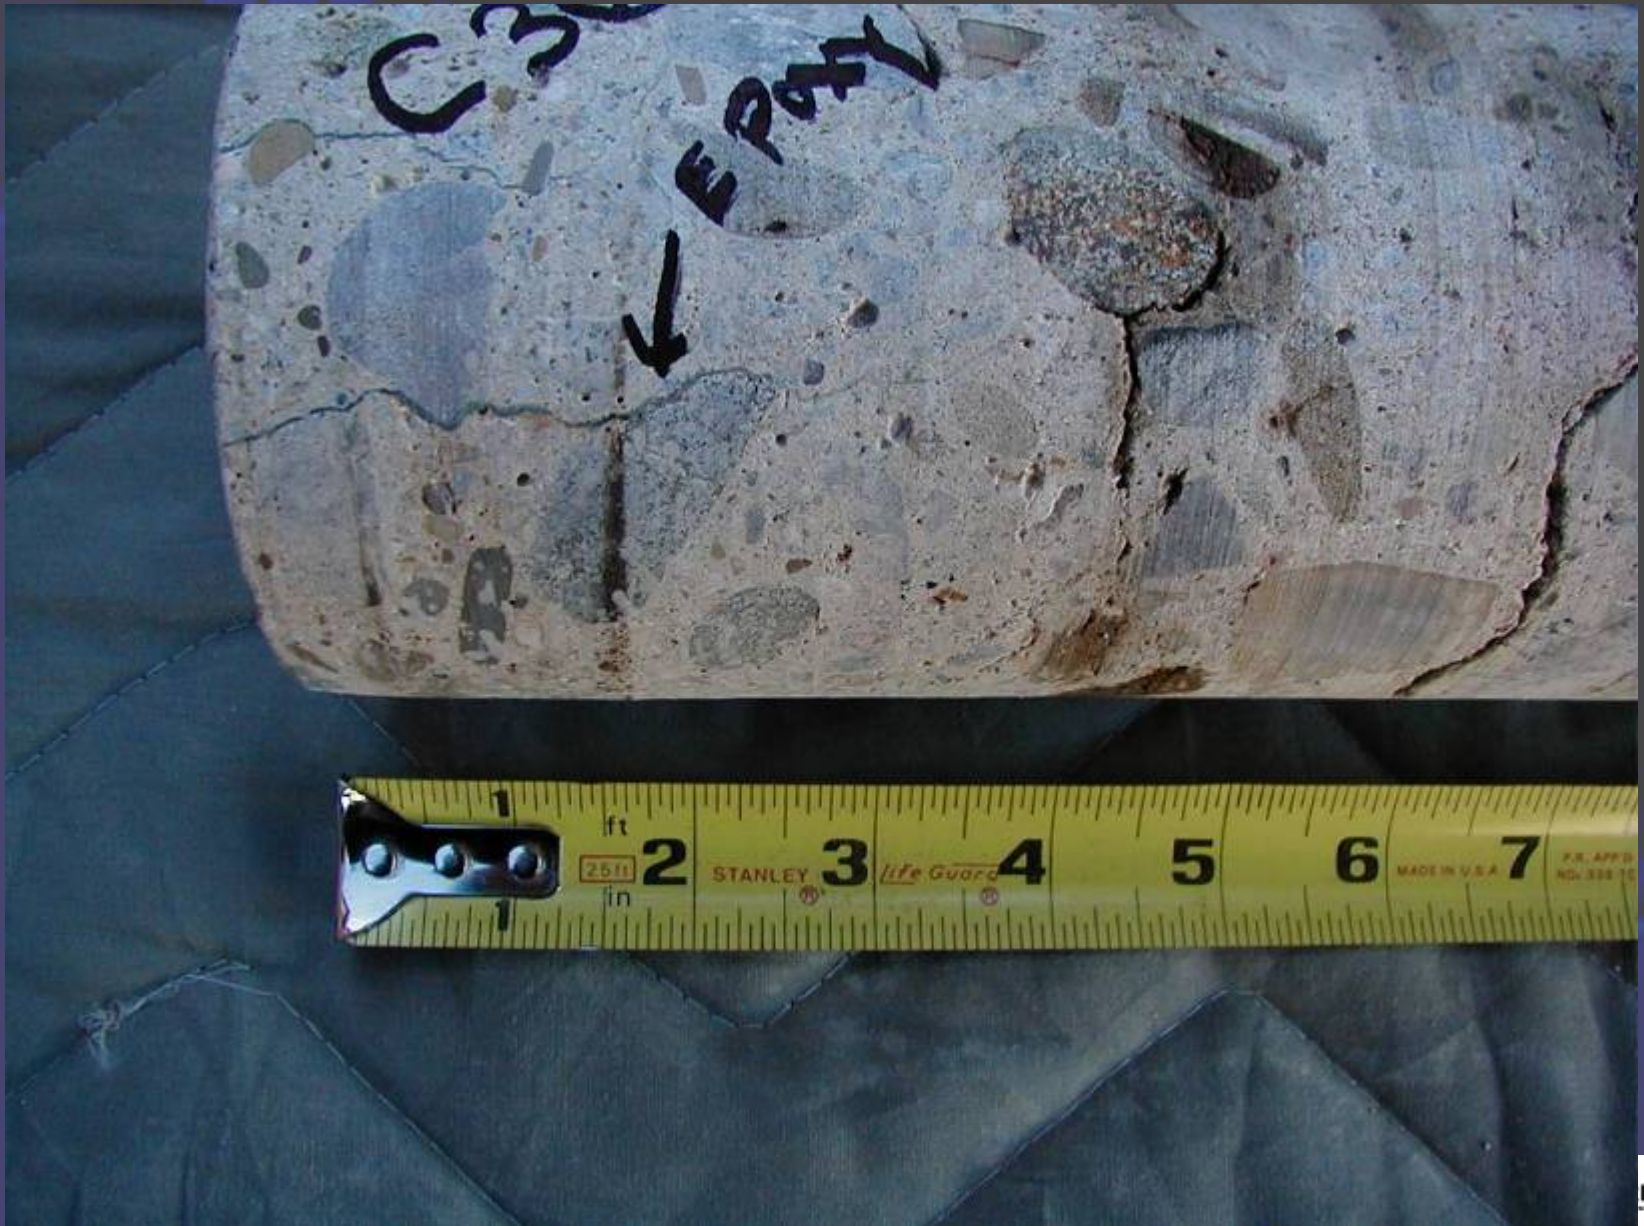
# Low Penetration of Epoxy

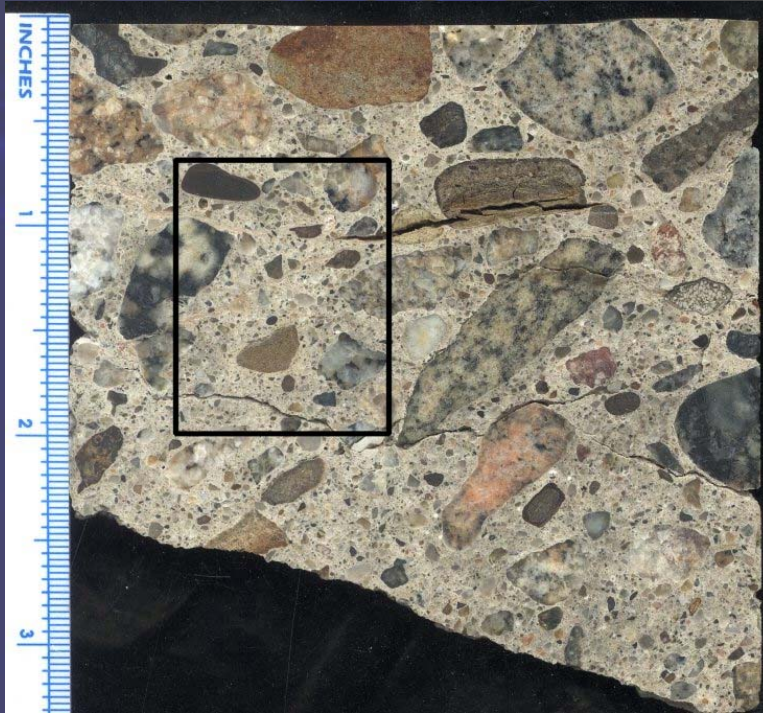
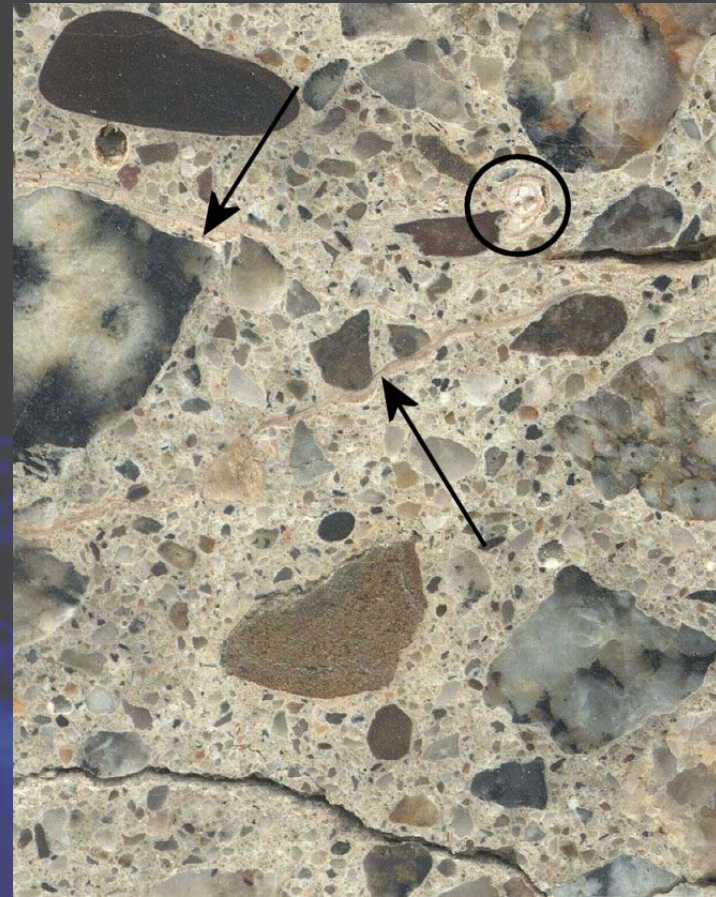
*Scanned images of polished section of Core P1 showing cracks in concrete caused by ASR. Image on right is a 4X magnification of rectangular area in the left image, which shows gel-filled cracks (marked with arrows) and a gel-filled void (marked with a circle).*

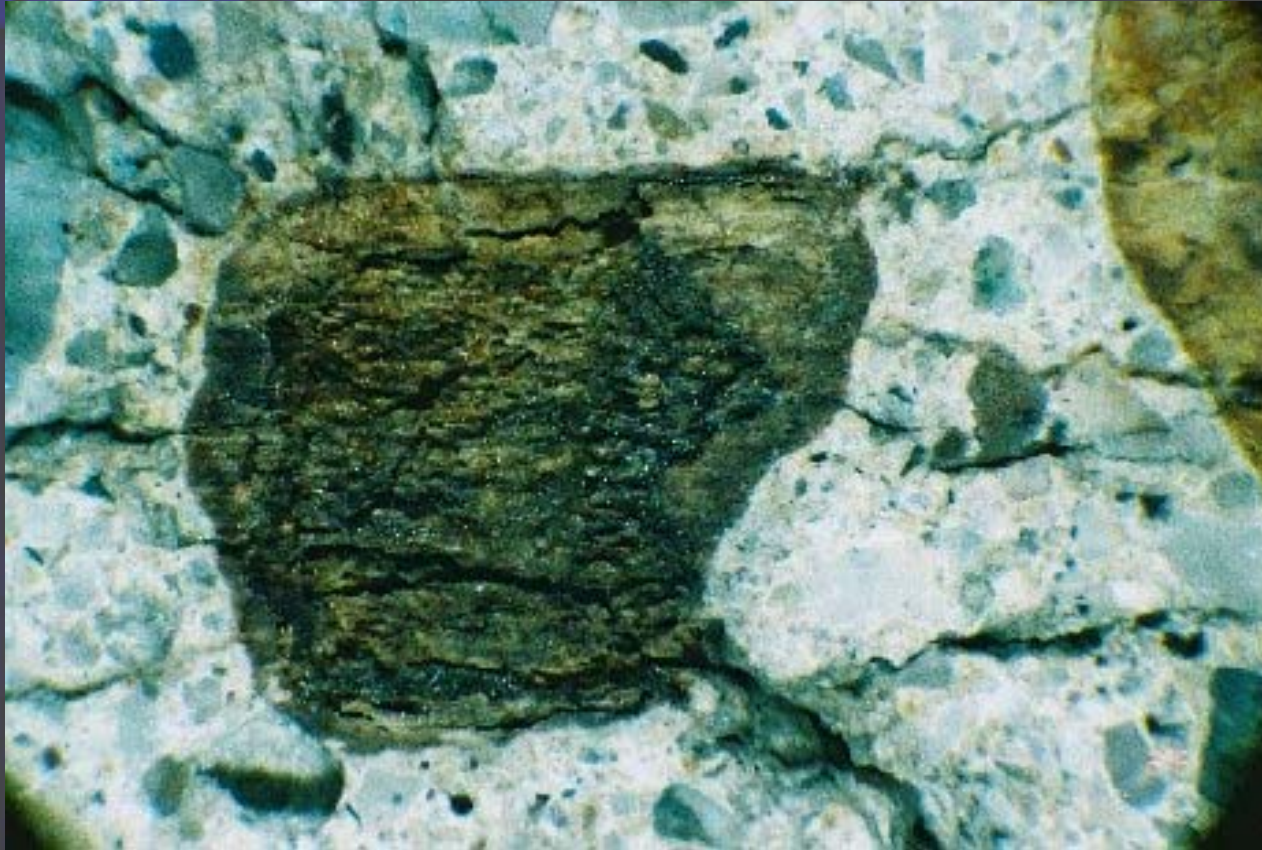
*A photograph showing a cracked volcanic rock particle in which the original texture is still visible. The crack extended outward from aggregate into the cementitious matrix.*

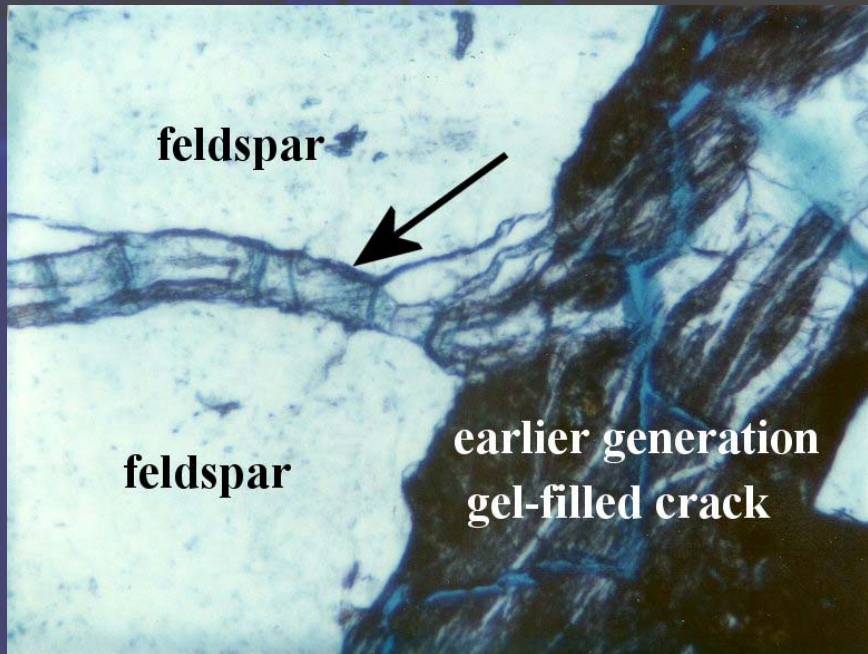
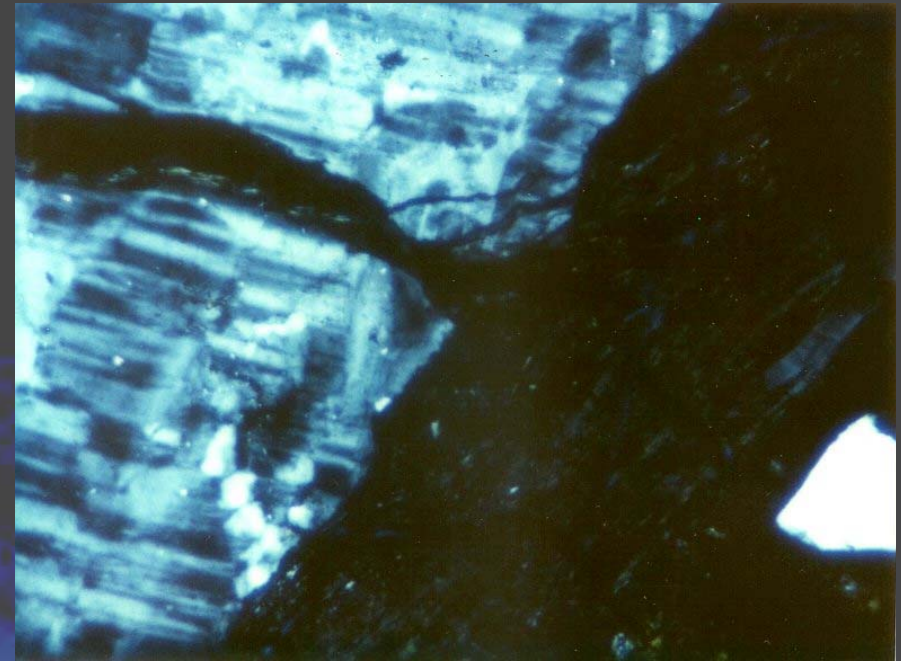
*Photomicrographs showing two generations of cracks and a feldspar particle. Photo on left (plane polarized light) shows two generations of cracks. Older crack (darker-colored gel) is to the right. Newer crack (lighter colored gel and marked with arrow) likely due to the reaction of the feldspar particle. Photo on the right (crossed polars) shows alkali-silica gel as typical dark extinction of amorphous materials. (100X)*

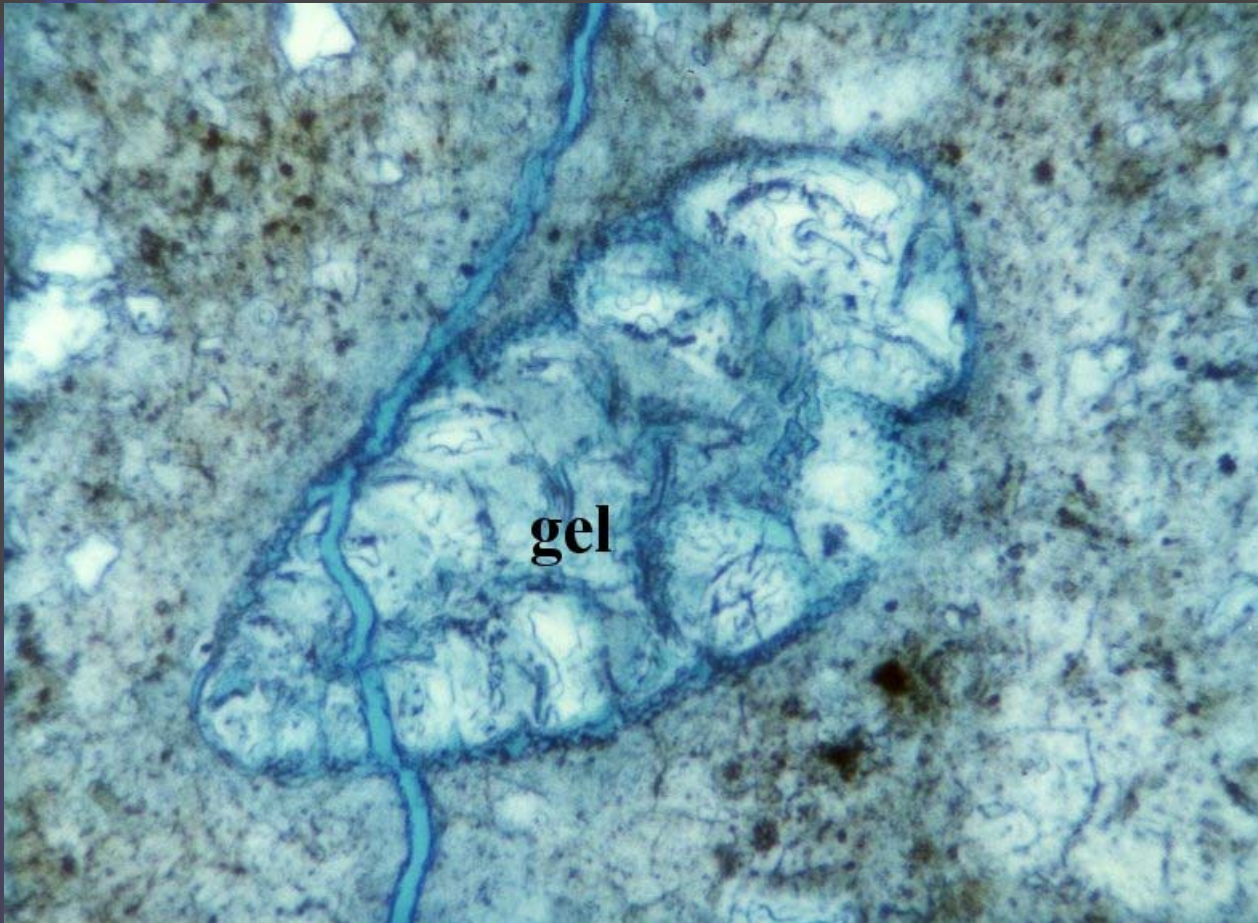
*Photomicrograph taken under a petrographic microscope showing a pocket of ASR gel inside a rhyolitic tuff aggregate particle. A later generation crack propagated through the aggregate and the gel pocket. (100X, plane polarized light)*

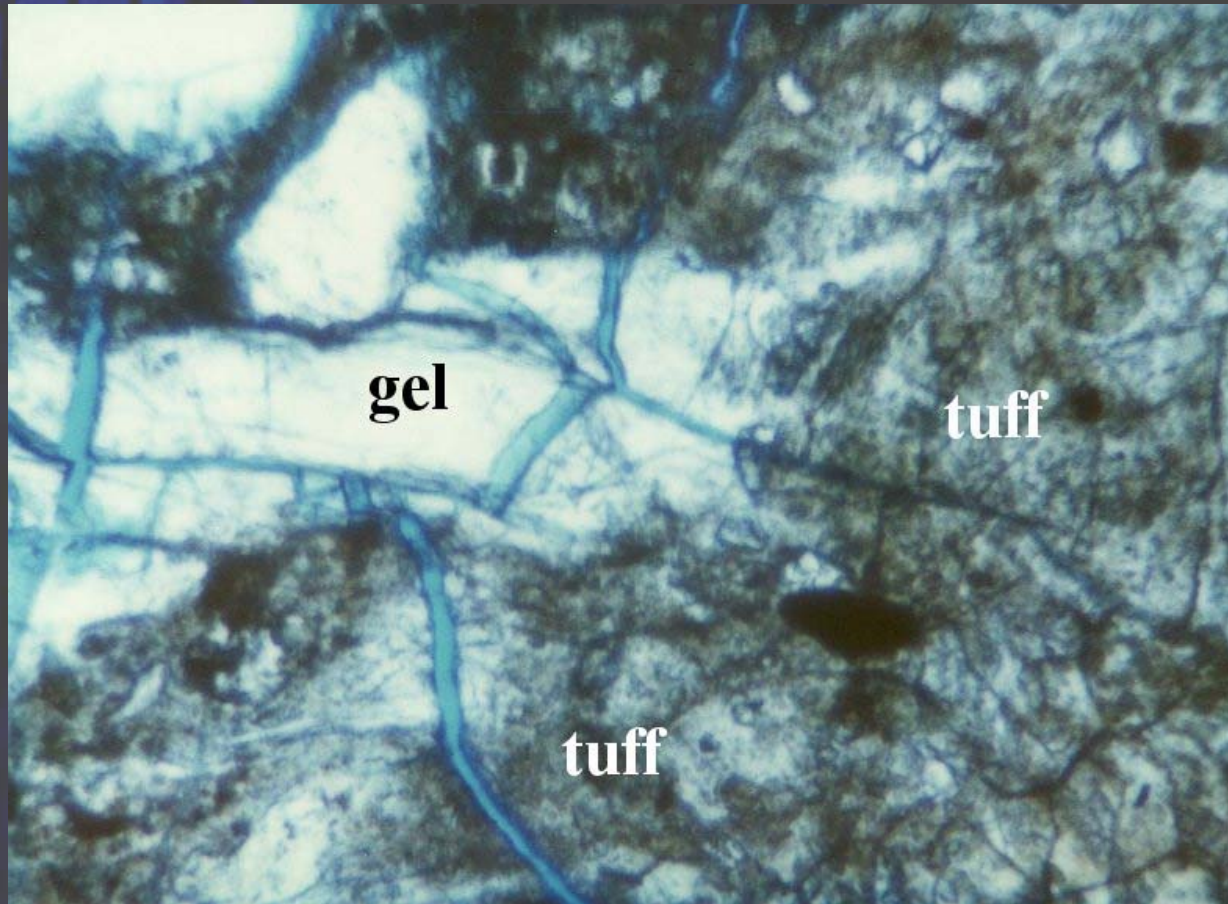
*Photomicrograph taken under a petrographic microscope showing alkali-silica gel exuding out of a rhyolitic tuff aggregate particle along a crack. (100X, plane polarized light)*

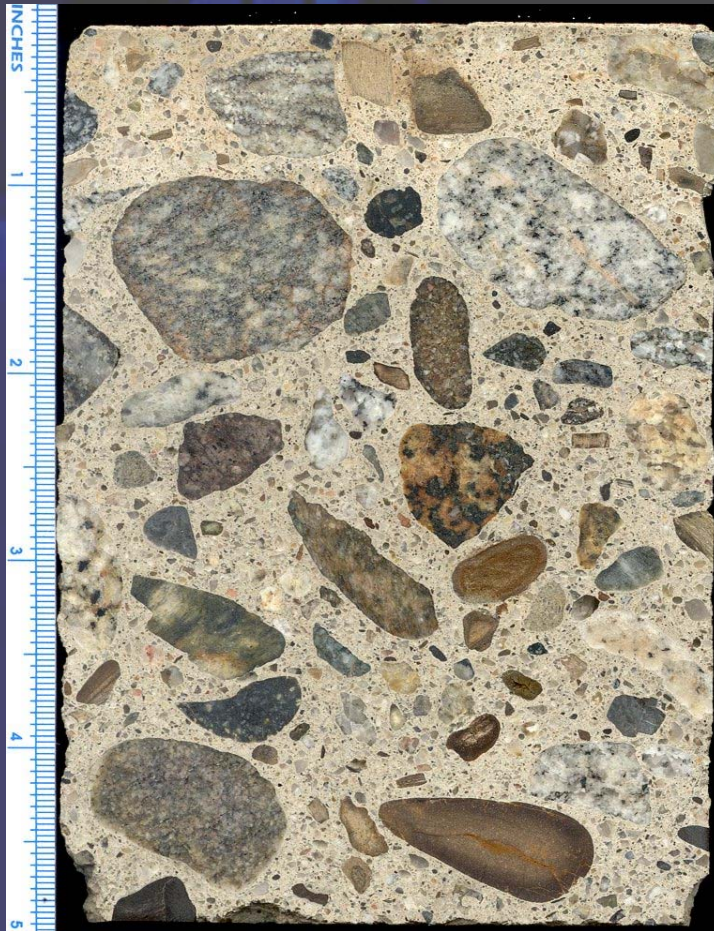
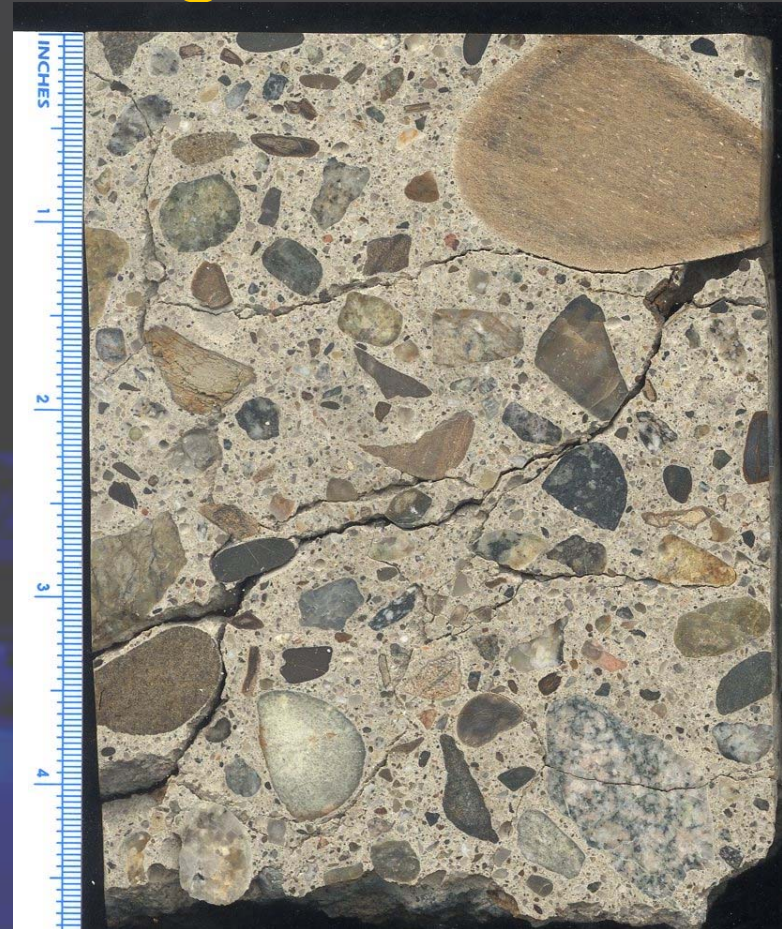
Scanned images of polished sections of Core P20 showing the difference in the degree of ASR deterioration between the top 0-5 inches (left) and the bottom 15-20 inches (right) of the core.
