# Sixth Street Viaduct Seismic Improvement Program Alkali Silica Reaction Workshop 8/27/08

# Alkali Silica Reaction (ASR) Material Finding at the Sixth Street Viaduct

# Visual Condition Survey

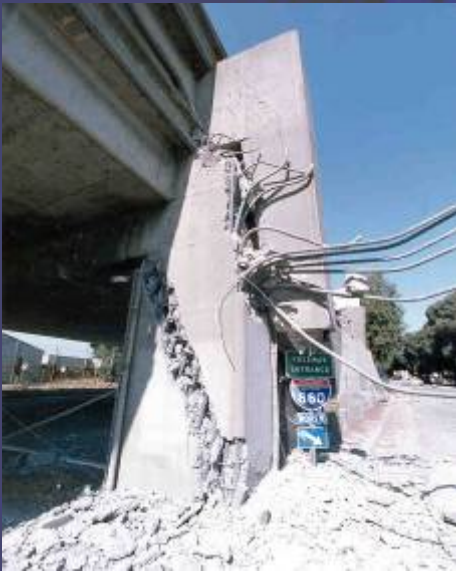
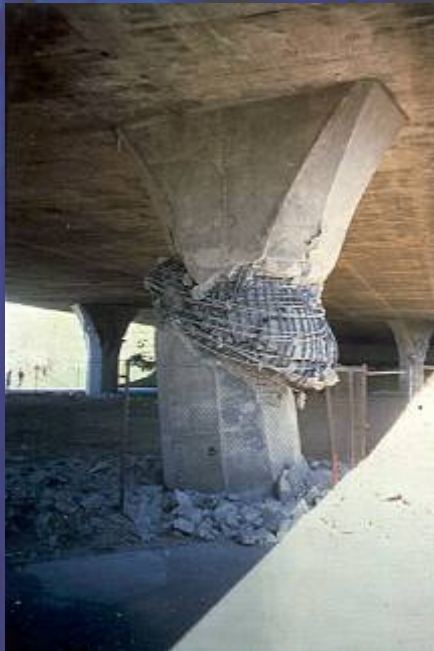
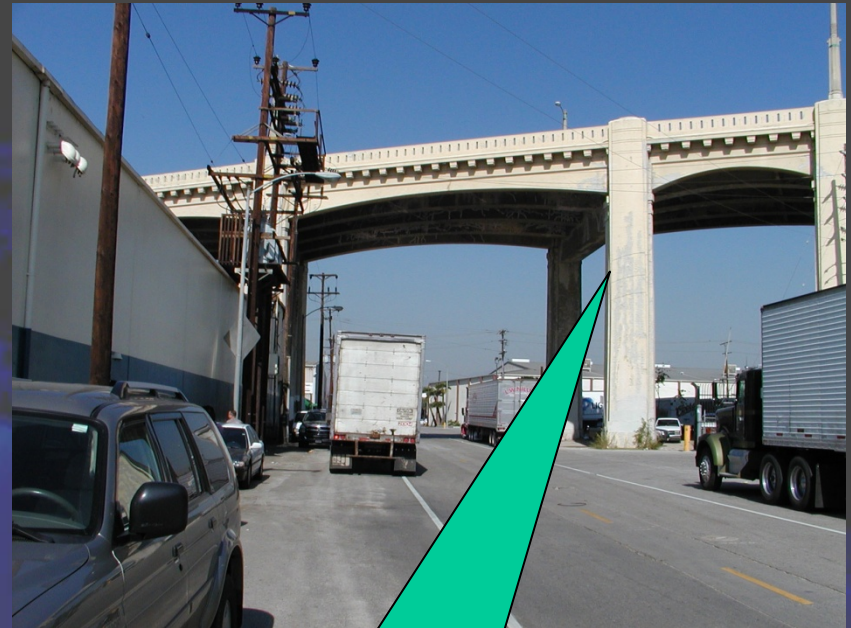
Column Flexural  
and Shear Failures

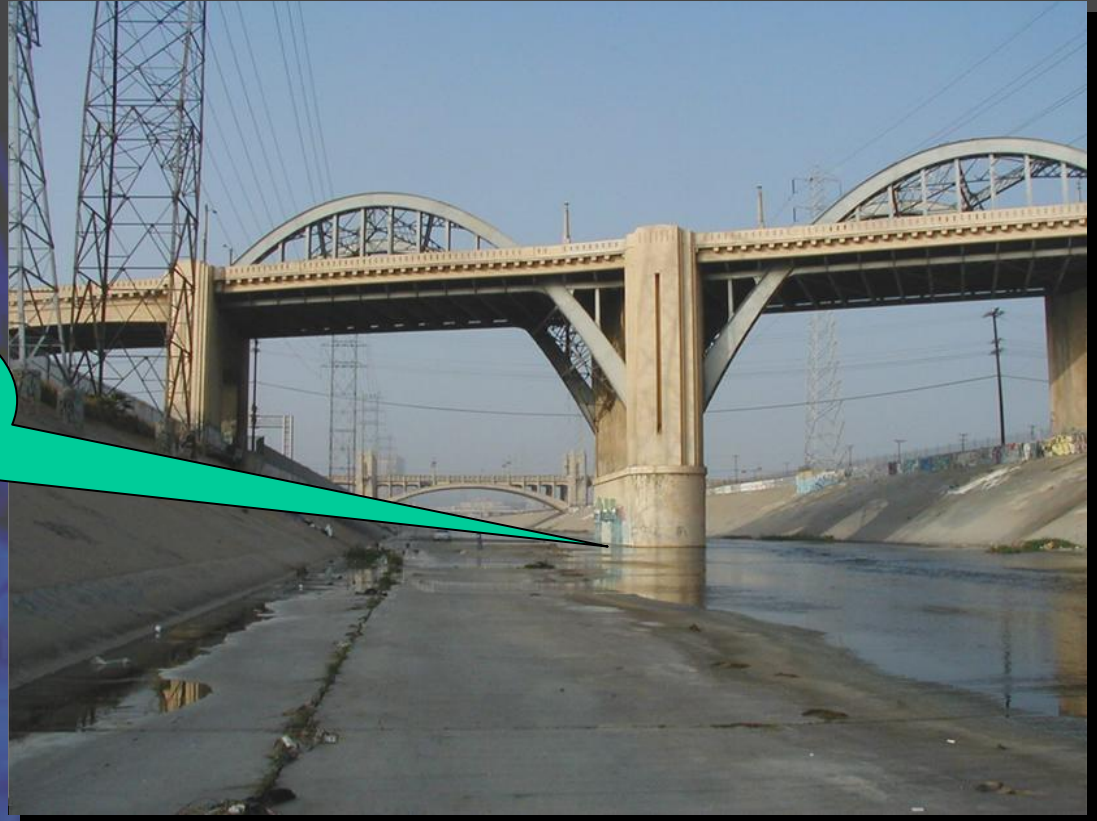
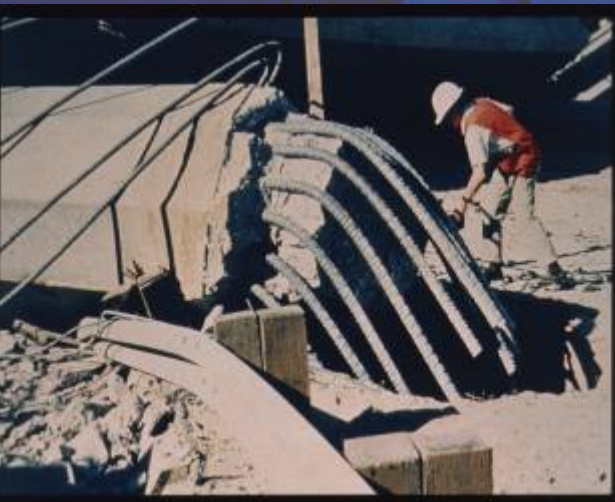
Column  
Reinforcing Steel  
Development

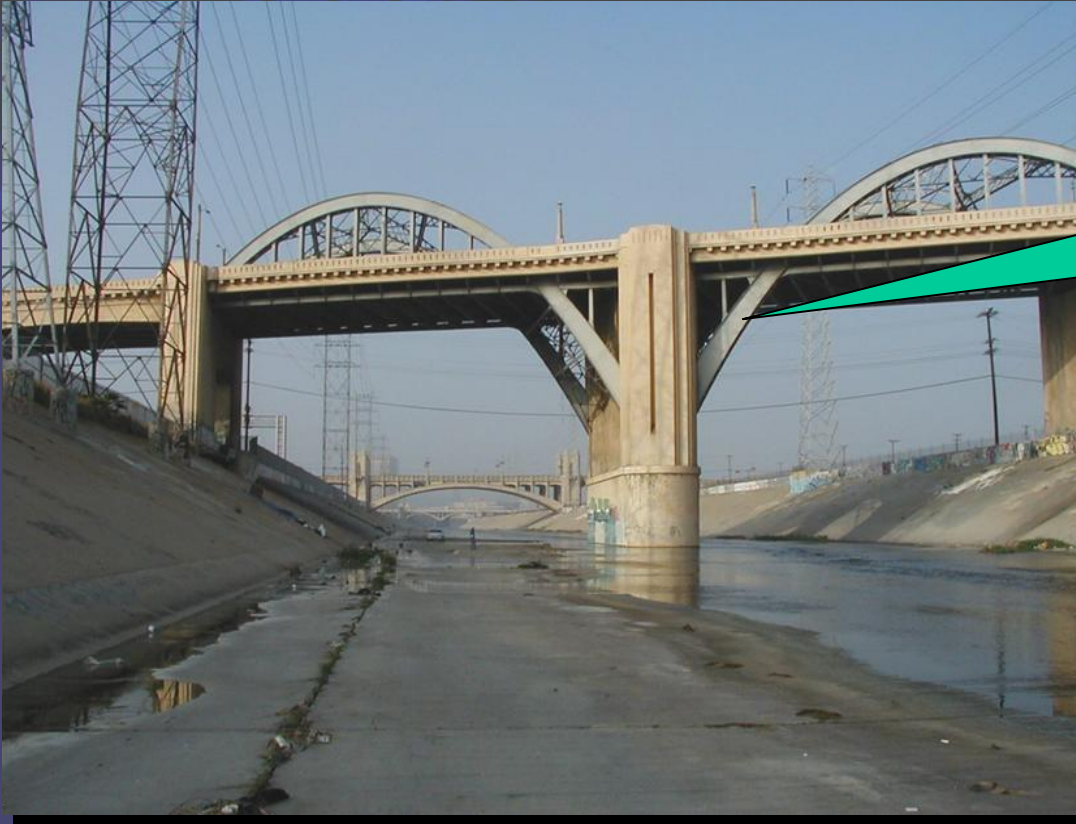
Buckling of  
Arch Ribs  
Members

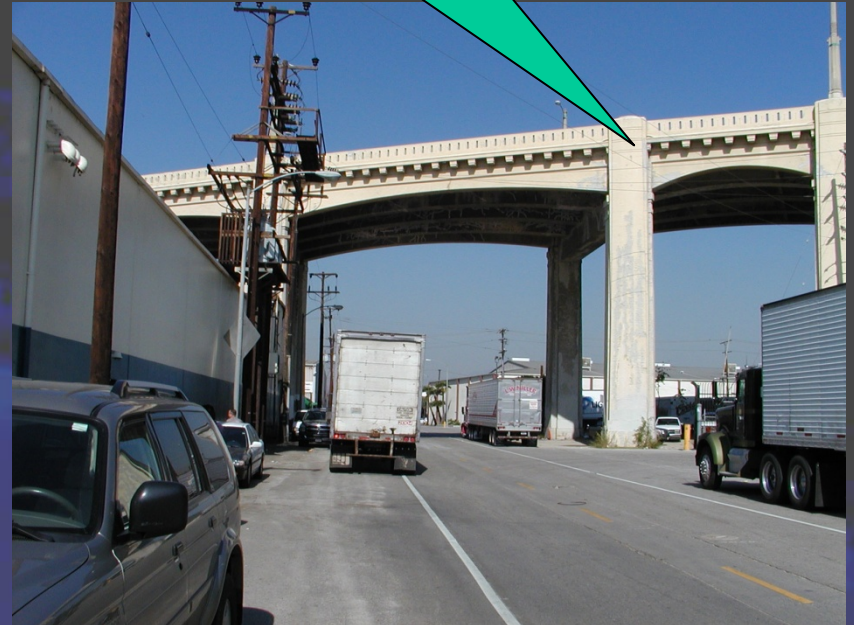
Joint Shear Failure
